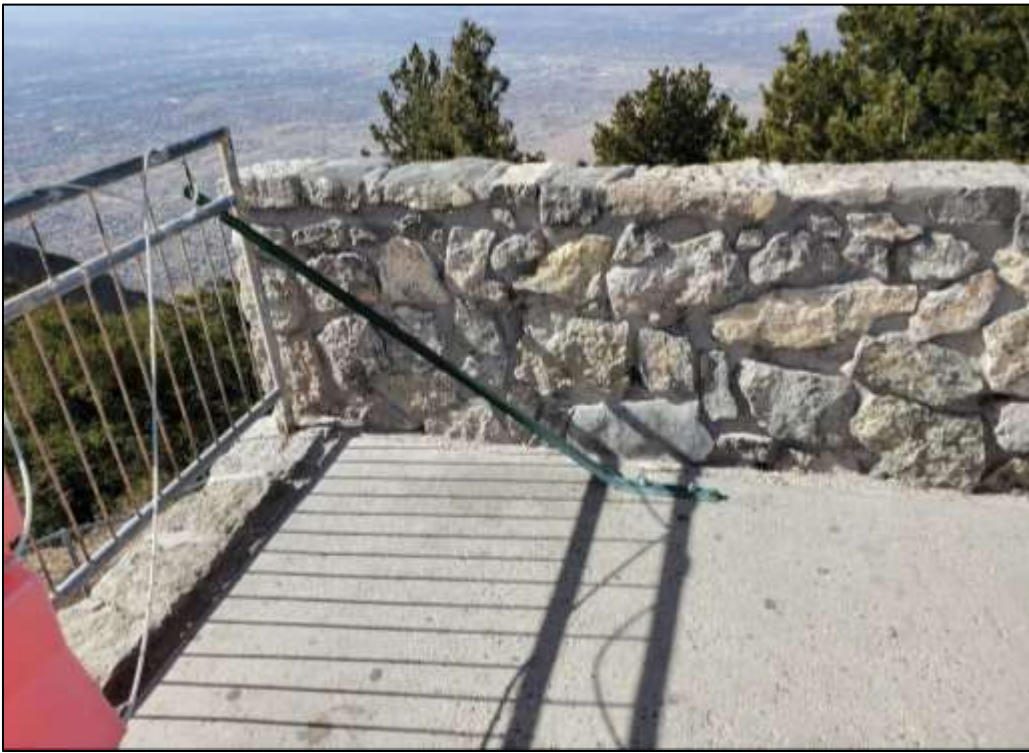
The right end of the railing was easy to secure, once the fencepost was cut, bent, and drilled.

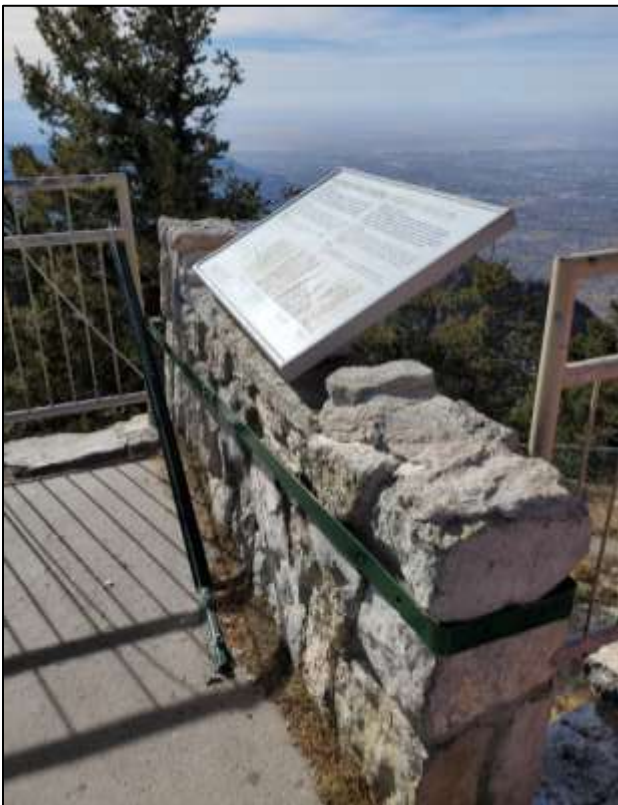
The post on the left side was not as easy and one of three possible options was implemented, securing the post to another railing on the observation deck which had been stabilized about three years ago by FOSM.

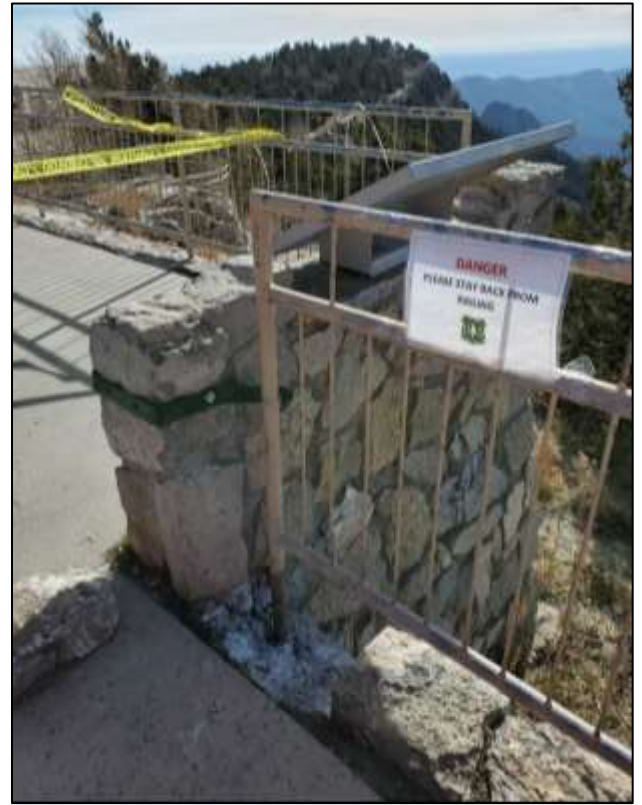
The steel band was wrapped around the wall and secured to the railing post. Then an anchor fastened the band to one of the mortar joints, luckily without breaking any more stones loose.

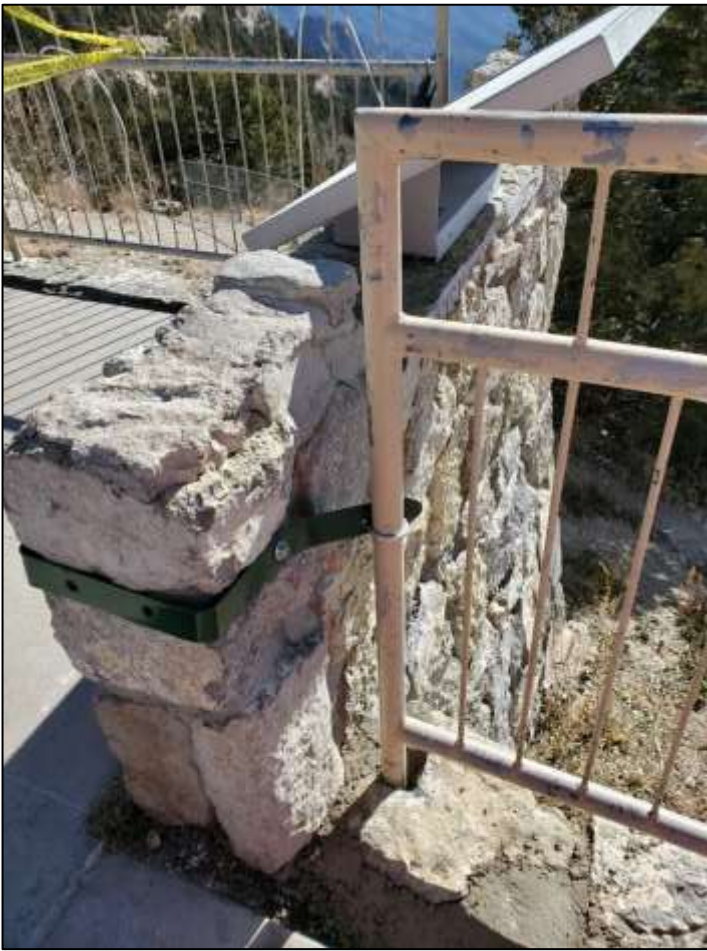
Not just the cap stones were loose. Enthusiastic visitors had managed to break loose a number of stones so repairs were needed below the top layer to fill a large gap in the stone work.

On the second work day, after the white adhesive material applied to the stone work in the previous photo was dry, the masonry was repaired, then some concrete was placed in the larger gaps.

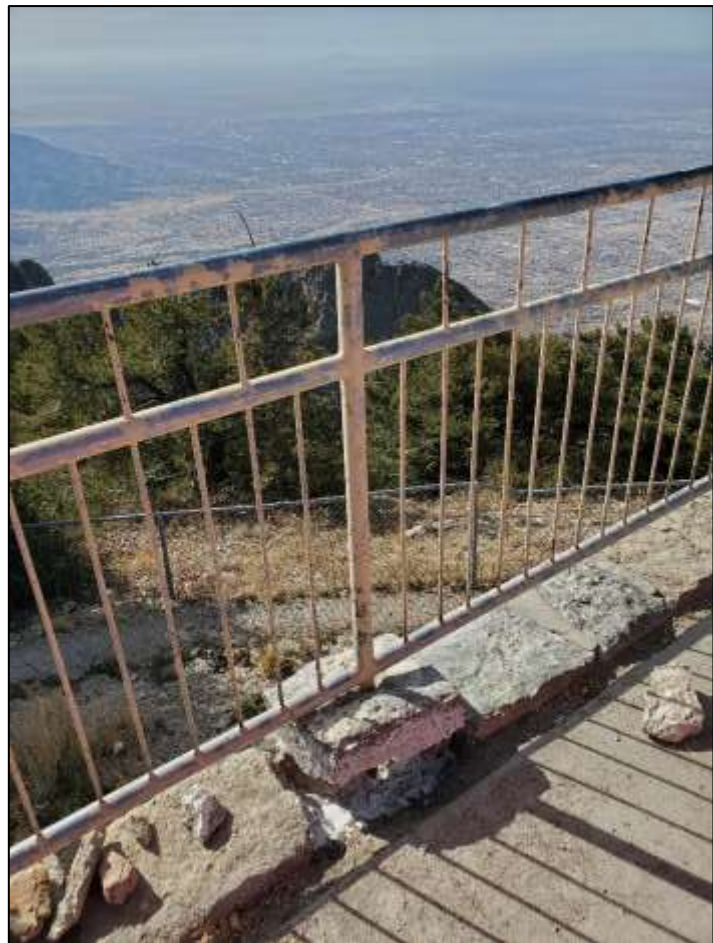
The middle post on the railing could not be braced very easily. Long ago a creative mason had drilled a hole through a chunk of limestone to help anchor it. Cleaning loose debris and applying the adhesive material required levitating the stone.

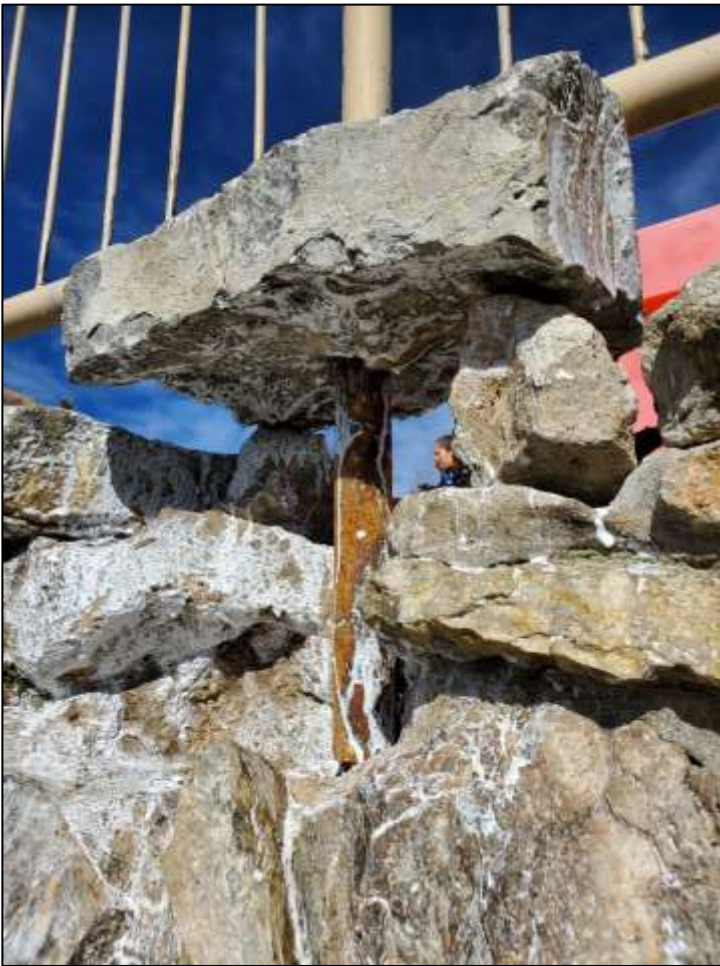
Ok, no magic in levitating the stone but we got it out of the way. Nothing appeared to be anchoring the center post but rust. We found using CAUTION tape was invaluable in keeping the many visitors from the work area.
