Report on Drainage Remediation on Un Poquito Trail

Tuesday, July 23rd, 2024

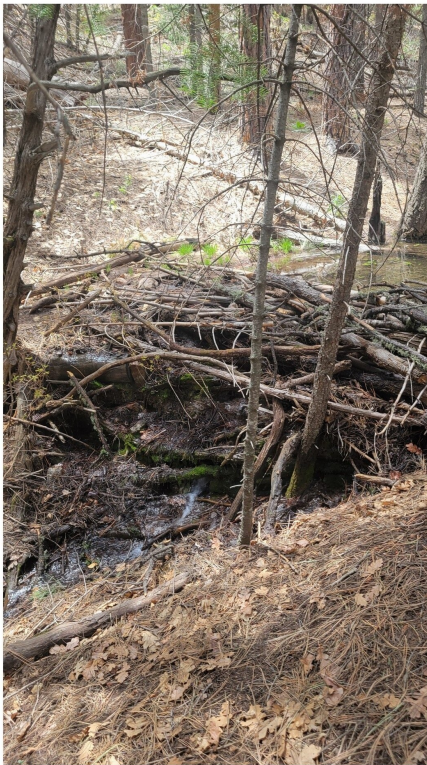
Artificial dam holds back water creating a pond

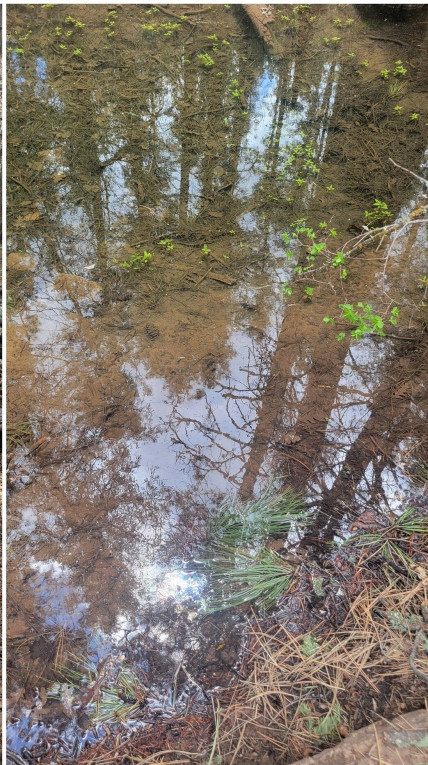
Temporal pond during spring run-off

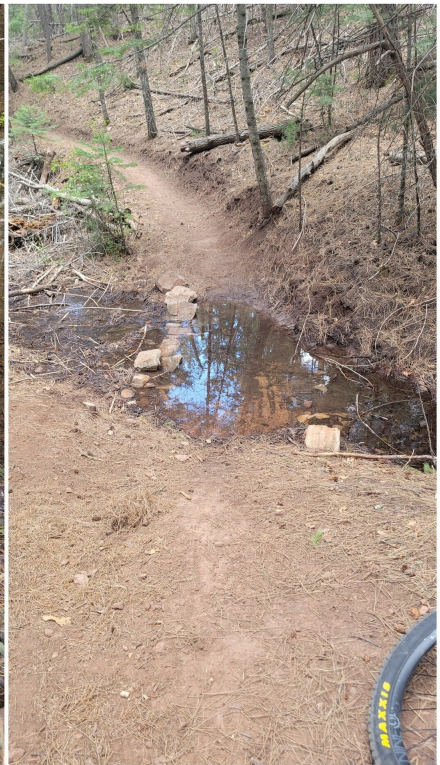
Resulting in a muddy drainage crossing leading to erosion

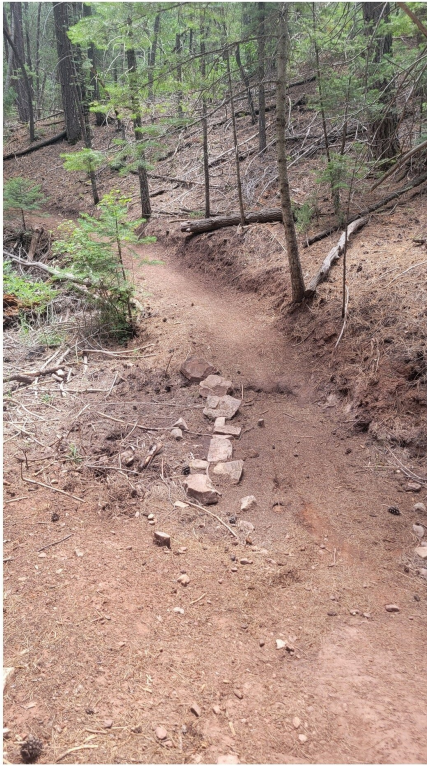
When dry extensive erosion of the trail as well as debris noted on outflow
