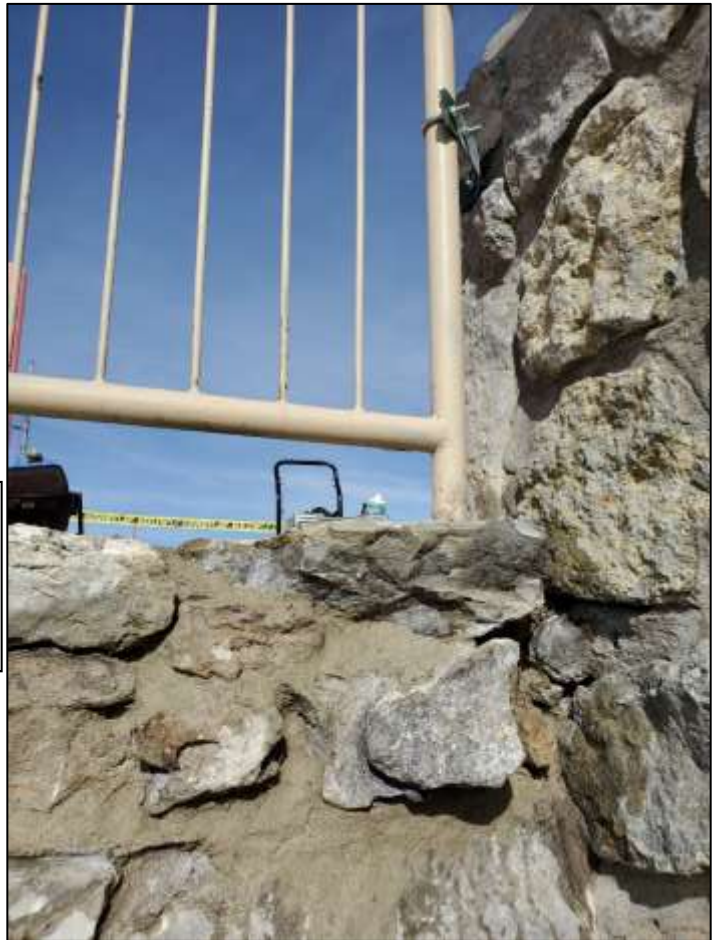
Not just the cap stones were loose. Enthusiastic visitors had managed to break loose a number of stones so repairs were needed below the top layer to fill a large gap in the stone work.

On the second work day, after the white adhesive material applied to the stone work in the previous photo was dry, the masonry was repaired, then some concrete was placed in the larger gaps.
