# **ROAD SAFETY AUDIT**

**Lead/Coal Ave Corridor  
(Washington St to Broadway Blvd)**

*June 10, 2022*

**Prepared for the City of Albuquerque**

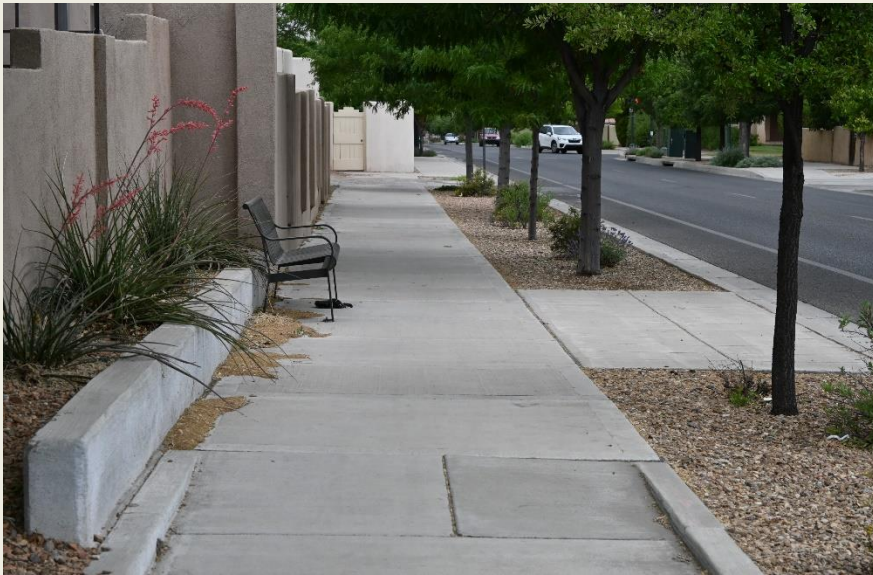
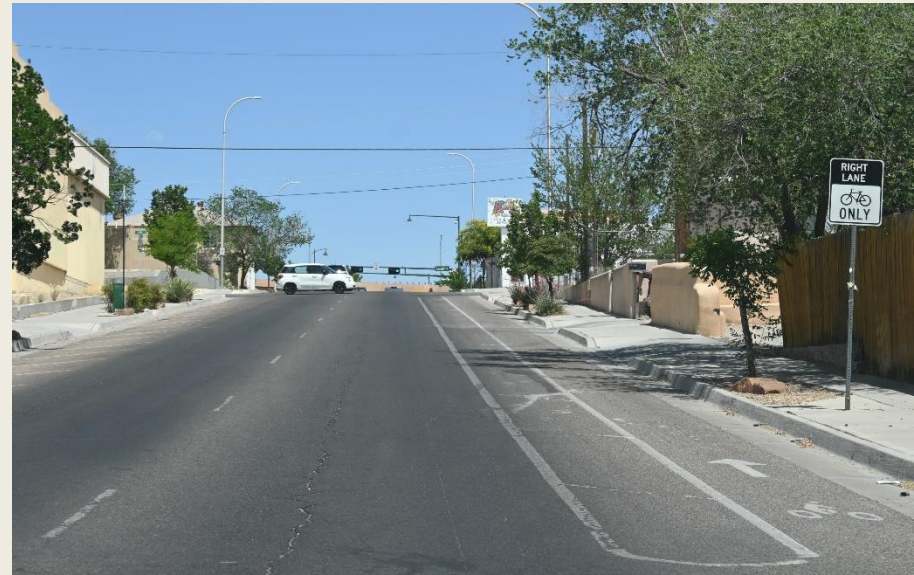
- Buffered sidewalks along the entire corridor that are also wide. Many sidewalks are also buffered by the bicycle lane.
- Trees along the corridor help visually narrow the corridor.
- Continuous bike lanes along the corridor (buffered in some locations).

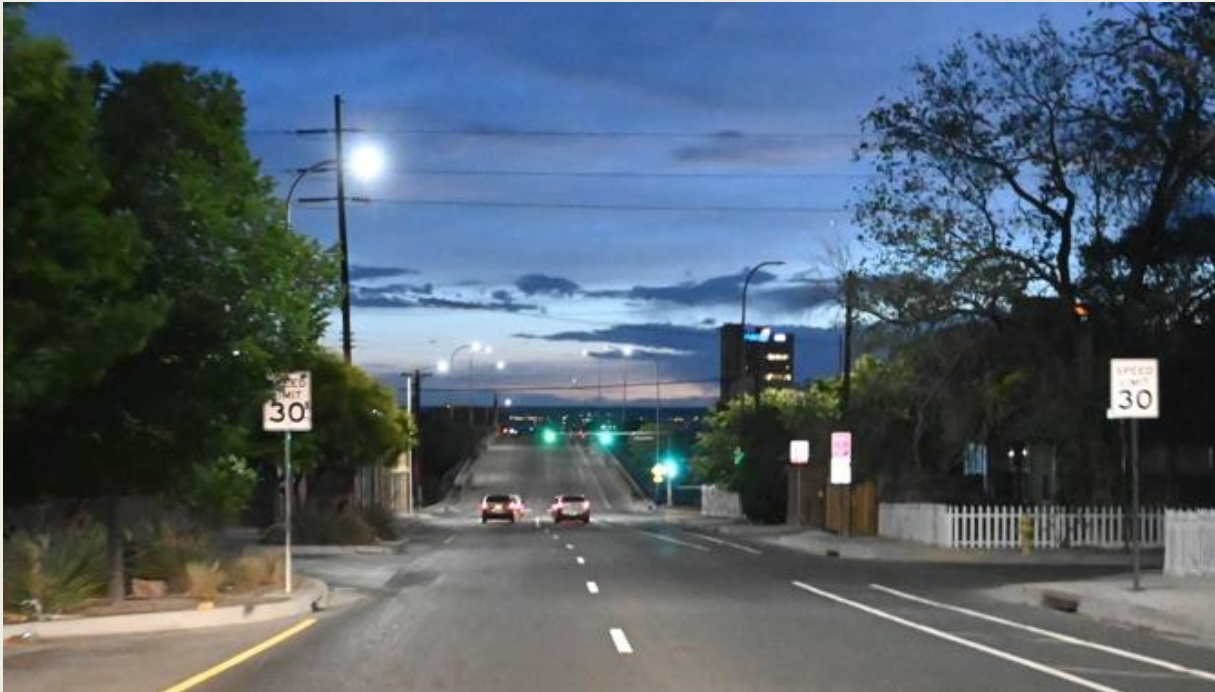
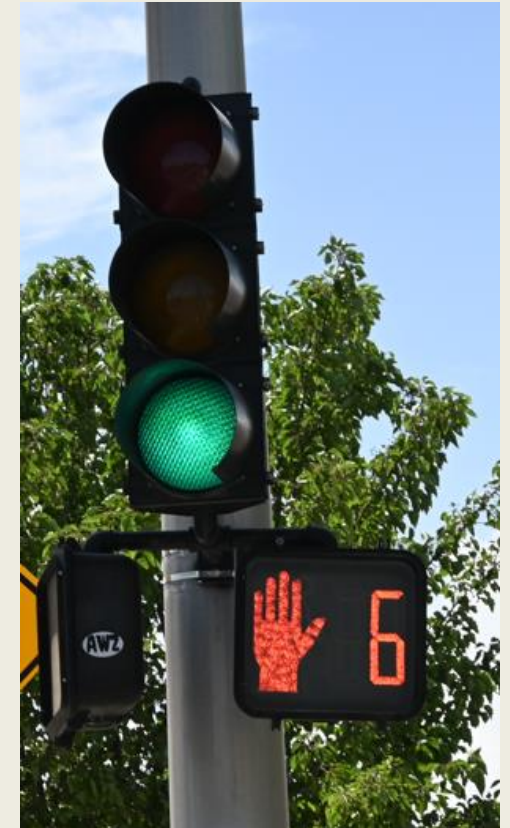
- Pedestrian signals count down at every signalized intersection.
- All intersections have lighting. Some pedestrian lighting at certain locations (i.e., Morningside Park).
- Pavement in good condition.

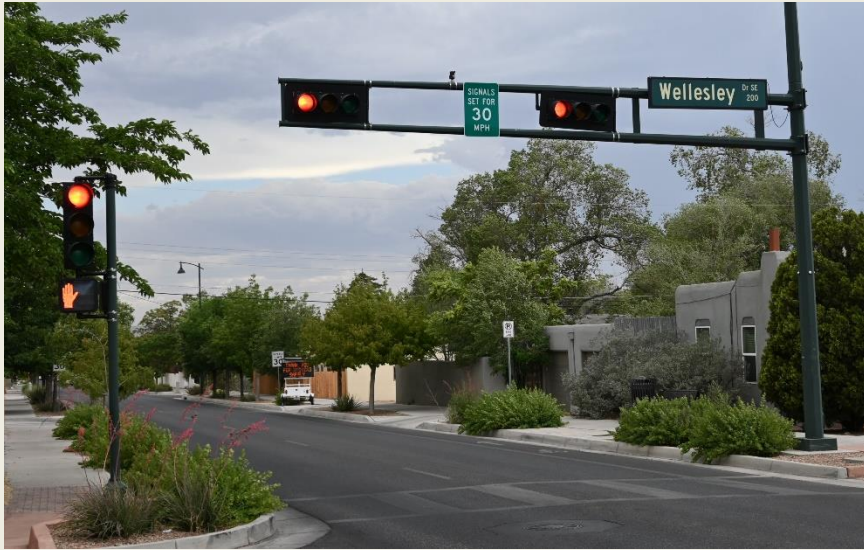
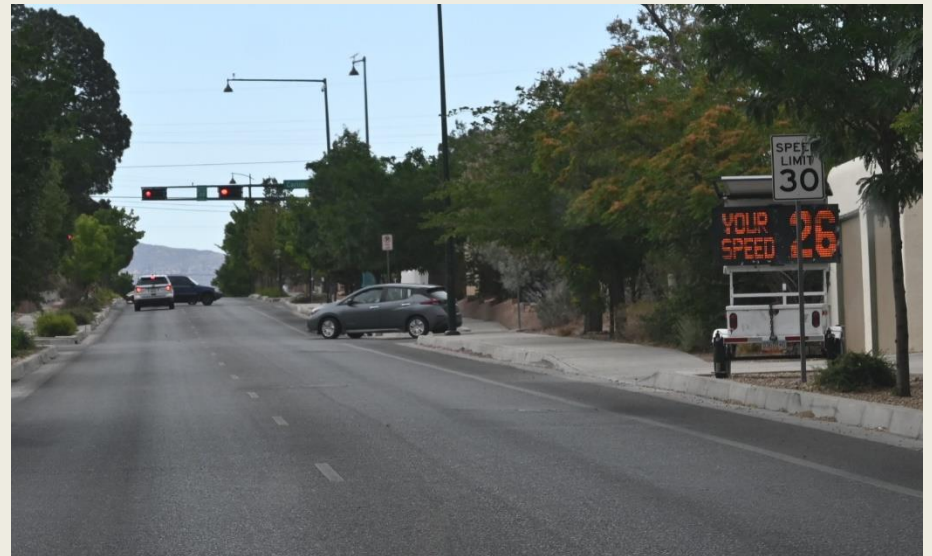
- Signals timed for 30 mph.
- 2 radar speed feedback trailers along the corridor.

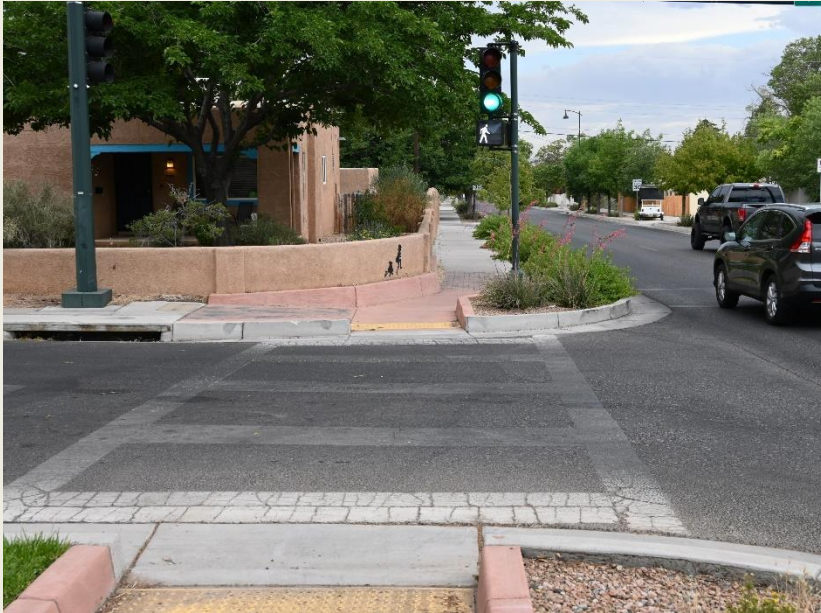
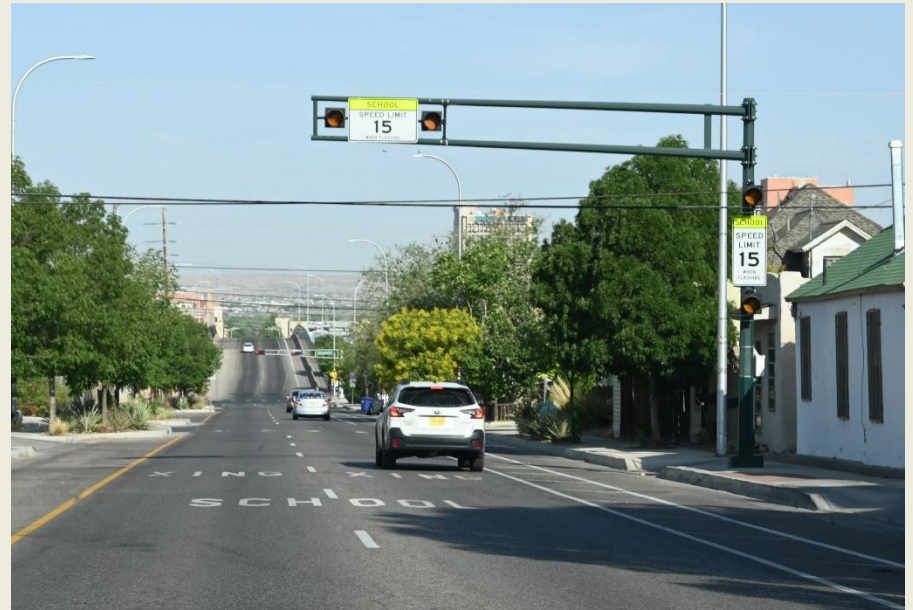
- 2 automated speed enforcement cameras are installed and will be activated soon.
- Sidewalks are accessible to people in wheelchairs.
- Advanced notice of school zones with overhead 15 mph flashing beacons.

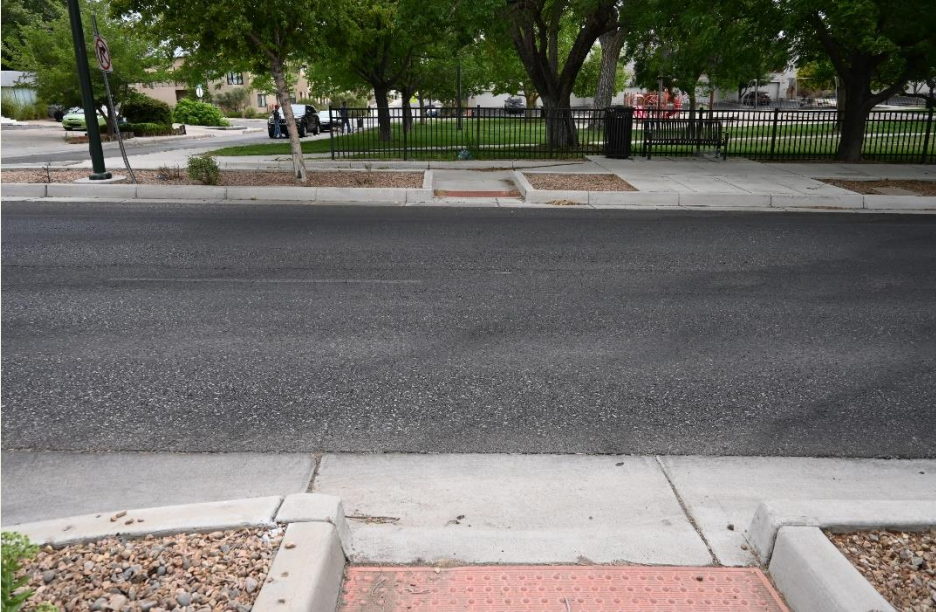
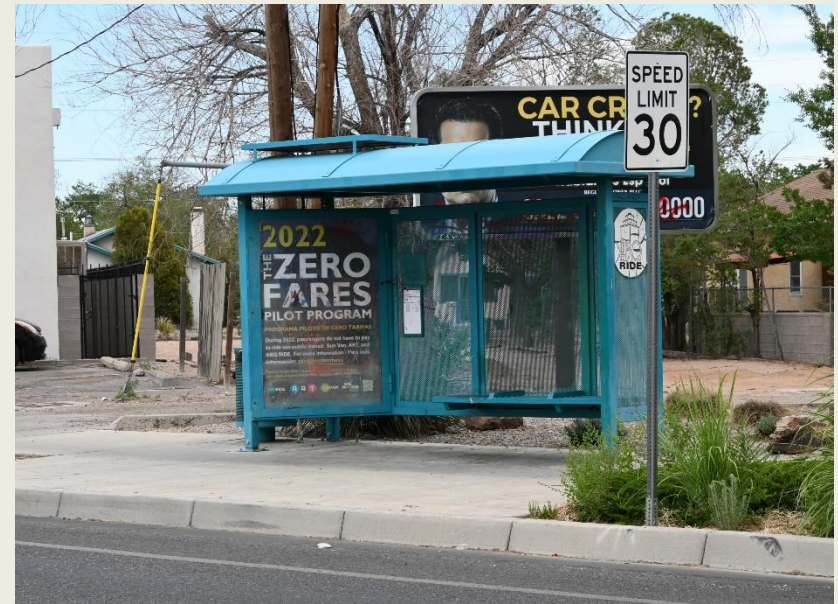
- Short crossing distance at most locations.
- Narrow lanes (10 ft for much of the corridor).
- Benches at some bus stops (and one with a shelter).

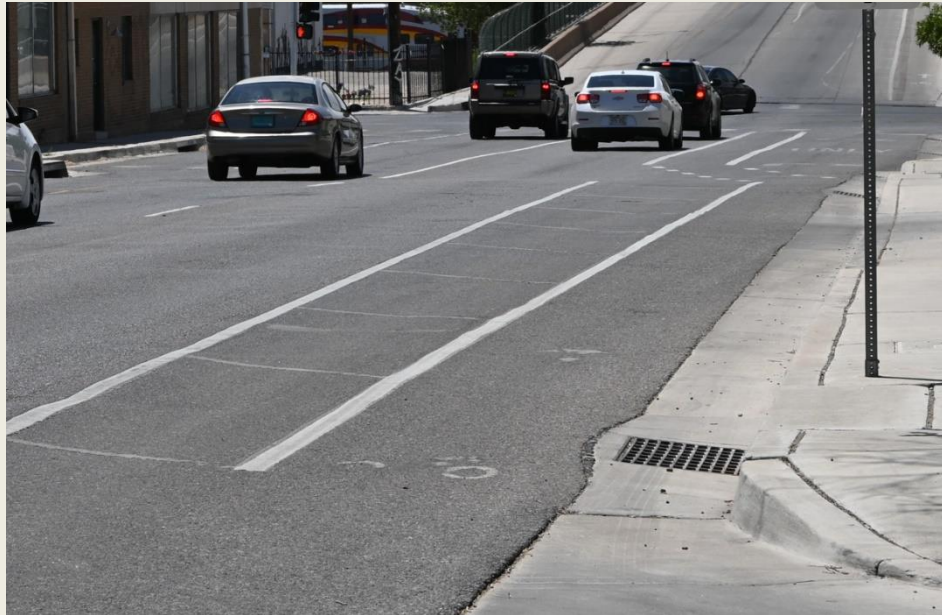
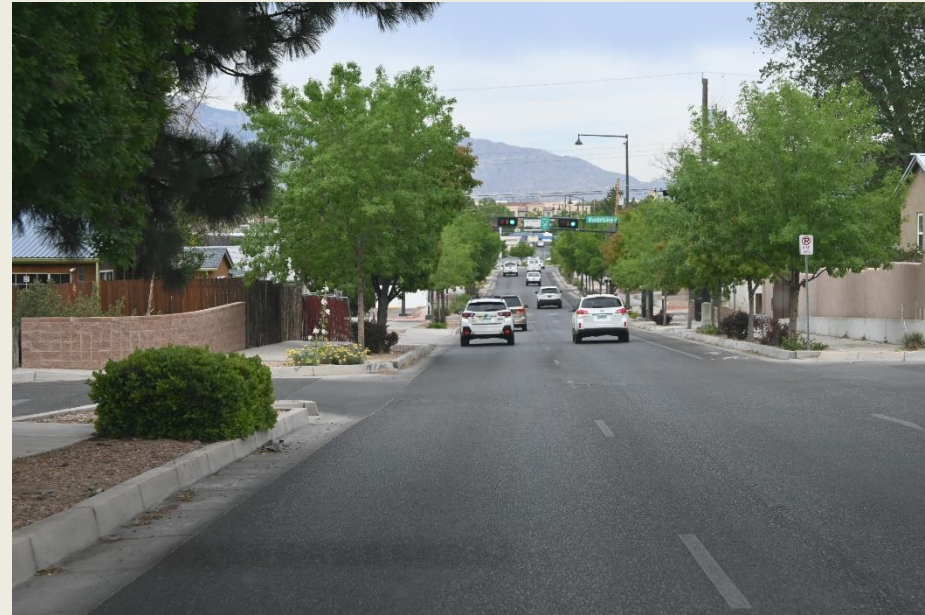
- Roosevelt Park and Morningside Park have signalized crossings.
- Bicycle-friendly drain grates.
- Nice landscaping.

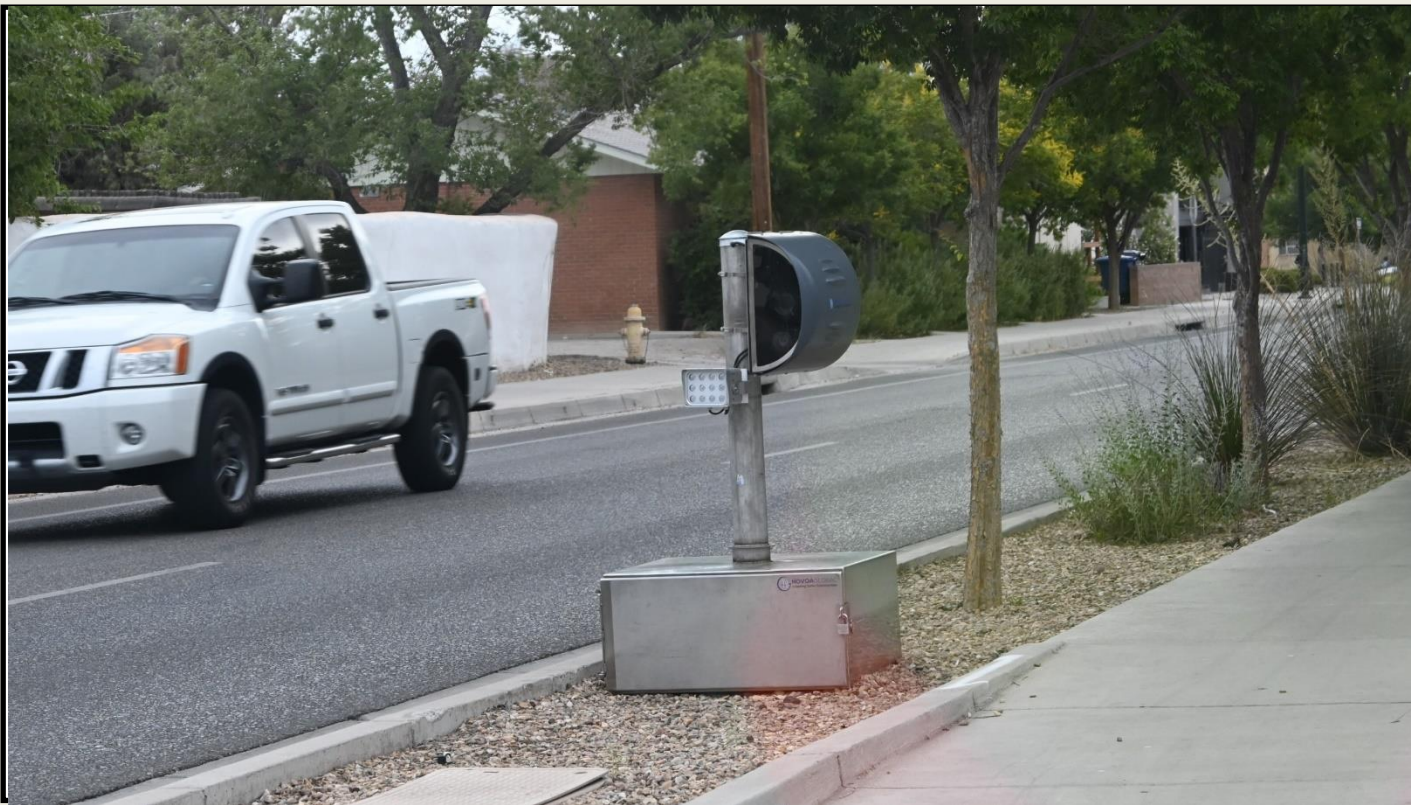
<b>FINDING</b>	<b>1</b>
EXPECTED FREQUENCY	<b>Frequent</b>
EXPECTED SEVERITY	<b>High</b>
RISK RATING	<b>F</b>

**OBSERVATION:** Lack of speed enforcement/consequences

- SUGGESTION:**
1. Use Automated Speed Enforcement. (ST)
  2. Add additional enforcement as needed. (ST)
  3. Recommend City Council consider passing supplemental penalties for speeding and creating a “safety corridor”. (MT)
  4. Educate judges on importance of supporting enforcement efforts. (ST)

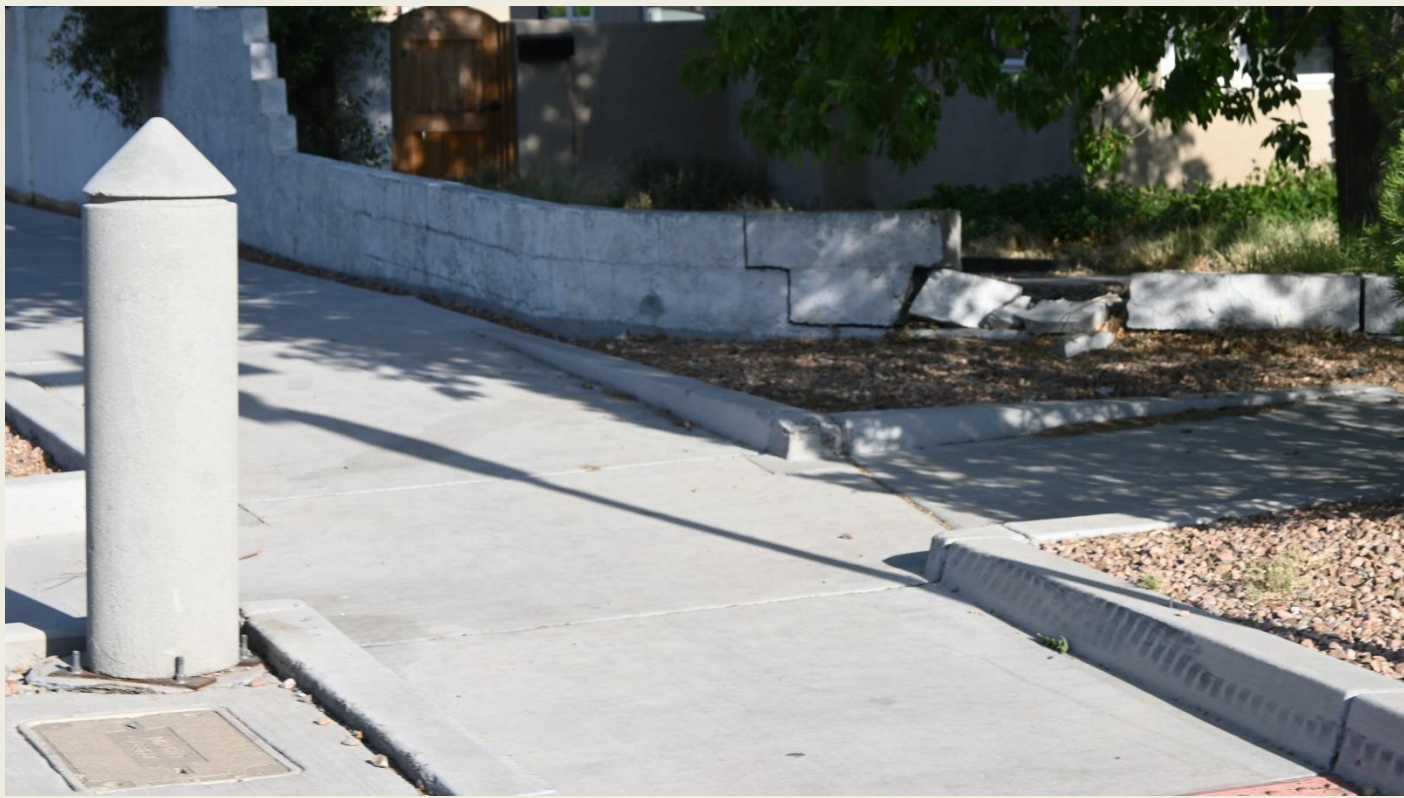
**OBSERVATION:** High speed crashes threaten homes along the corridor and their inhabitants

1. Recommend 25 mph speed limit throughout the corridor with 25 mph speed progression (ST)
2. Study one-lane option per roadway (MT)
3. Reevaluate One lane in each direction per roadway (MT)

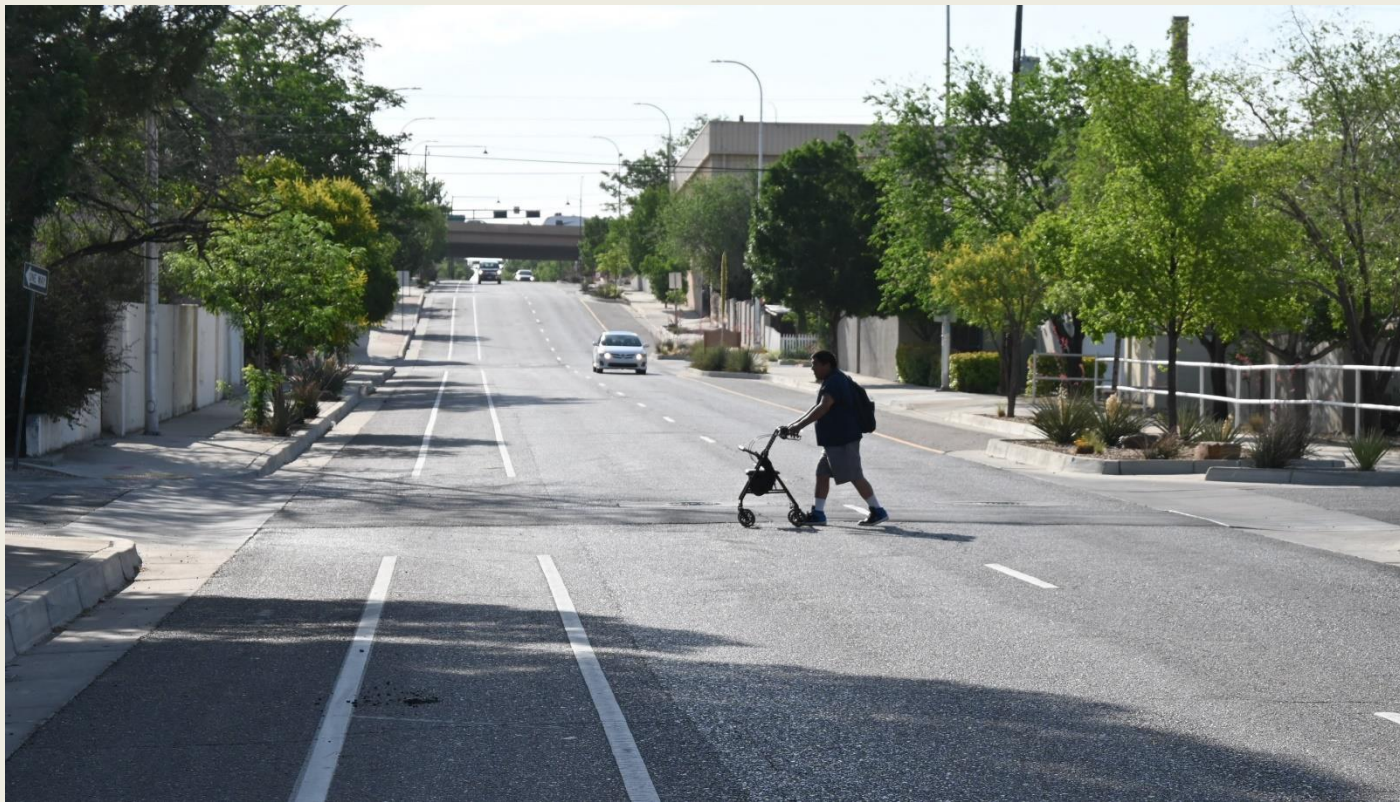
**OBSERVATION:** Speeding poses a higher threat to non-motorists

1. Consider raised crosswalks/table and speed cushions at select locations. (ST)
2. For one lane option, consider wider buffered bicycle lane with vertical element where possible. (MT)
3. Continue implementing Rest in Red. (ST)

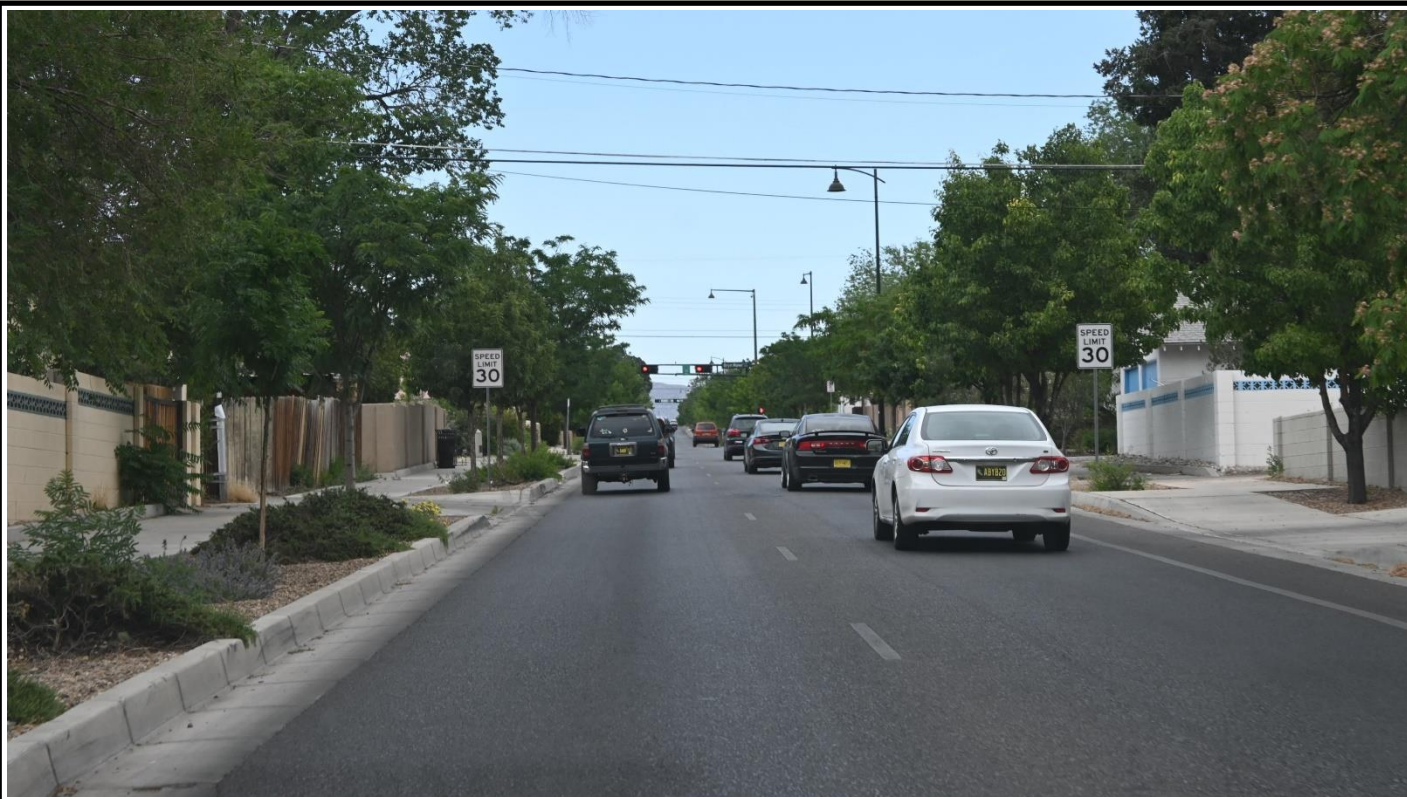
**OBSERVATION:** Driveways and alleys along the roadway create conflict points

1. Slower speeds will help mitigate issues associated with these movements
2. One-lane option would reduce conflict points

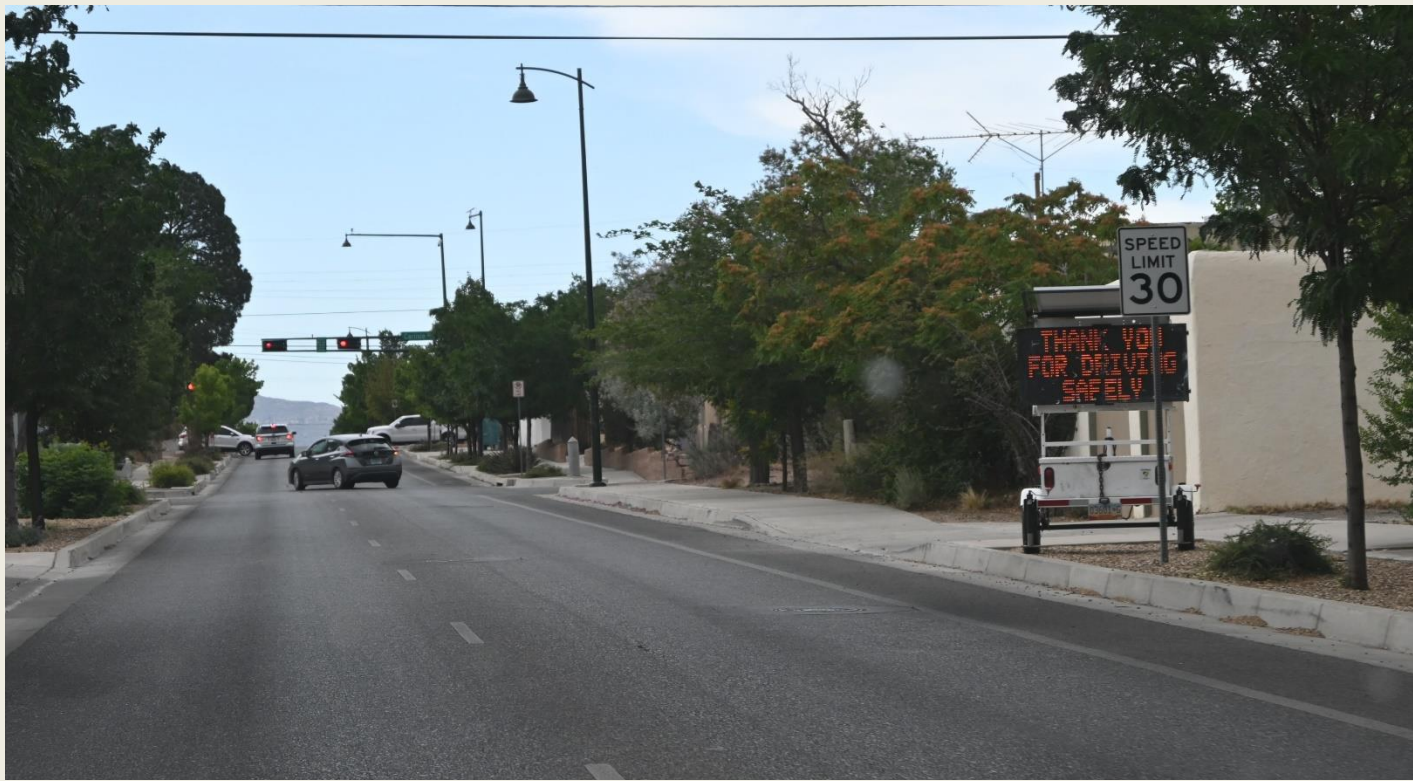
**OBSERVATION: Noise**

1. With speed reduction, noise would be reduced.
2. Speed tables/humps are likely to increase noise at those locations.

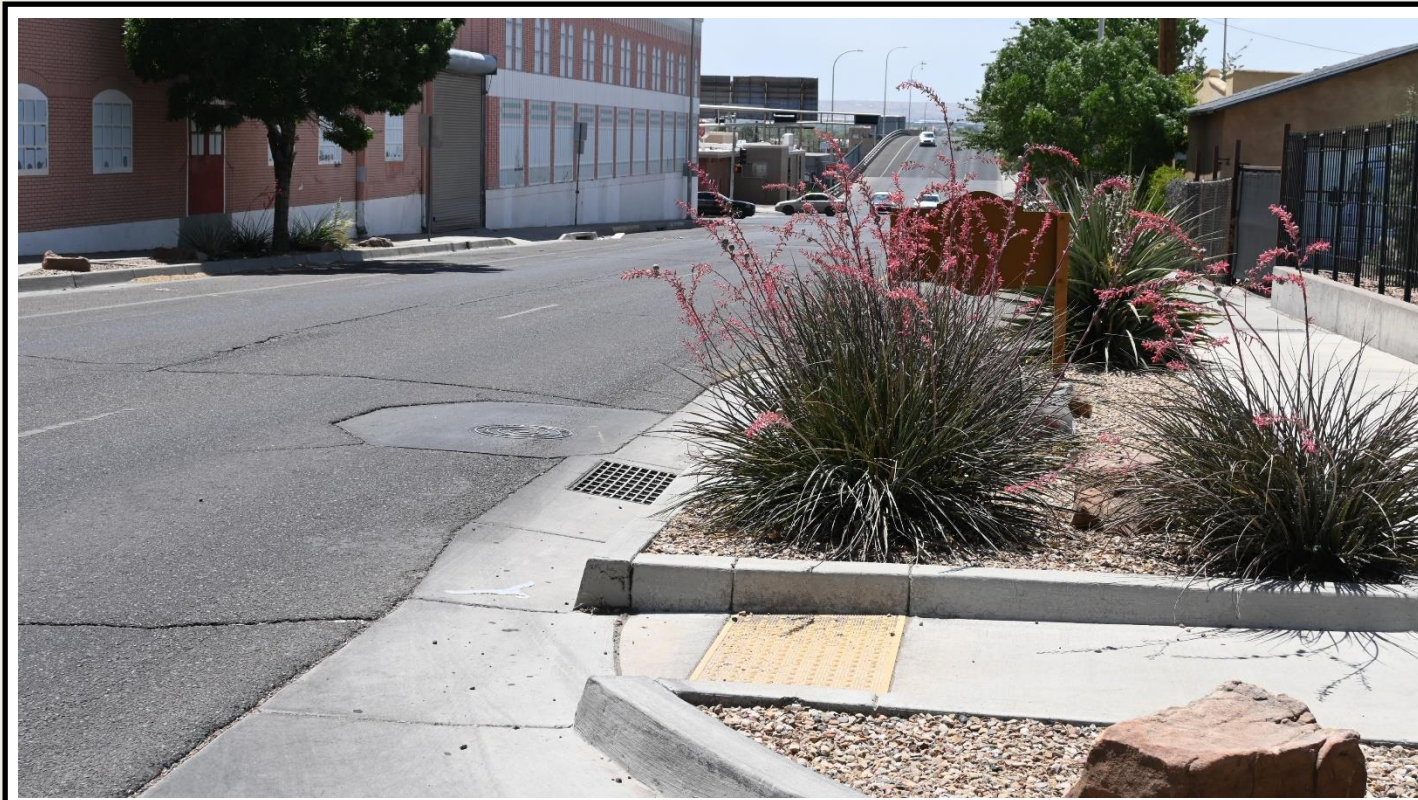
**OBSERVATION:** Limited sight distance at certain intersections (for motorists and pedestrians).

**SUGGESTION:**  
1. Evaluate each intersection for landscaping and tree trimming and/or removal as well as other obstructions. (ST)

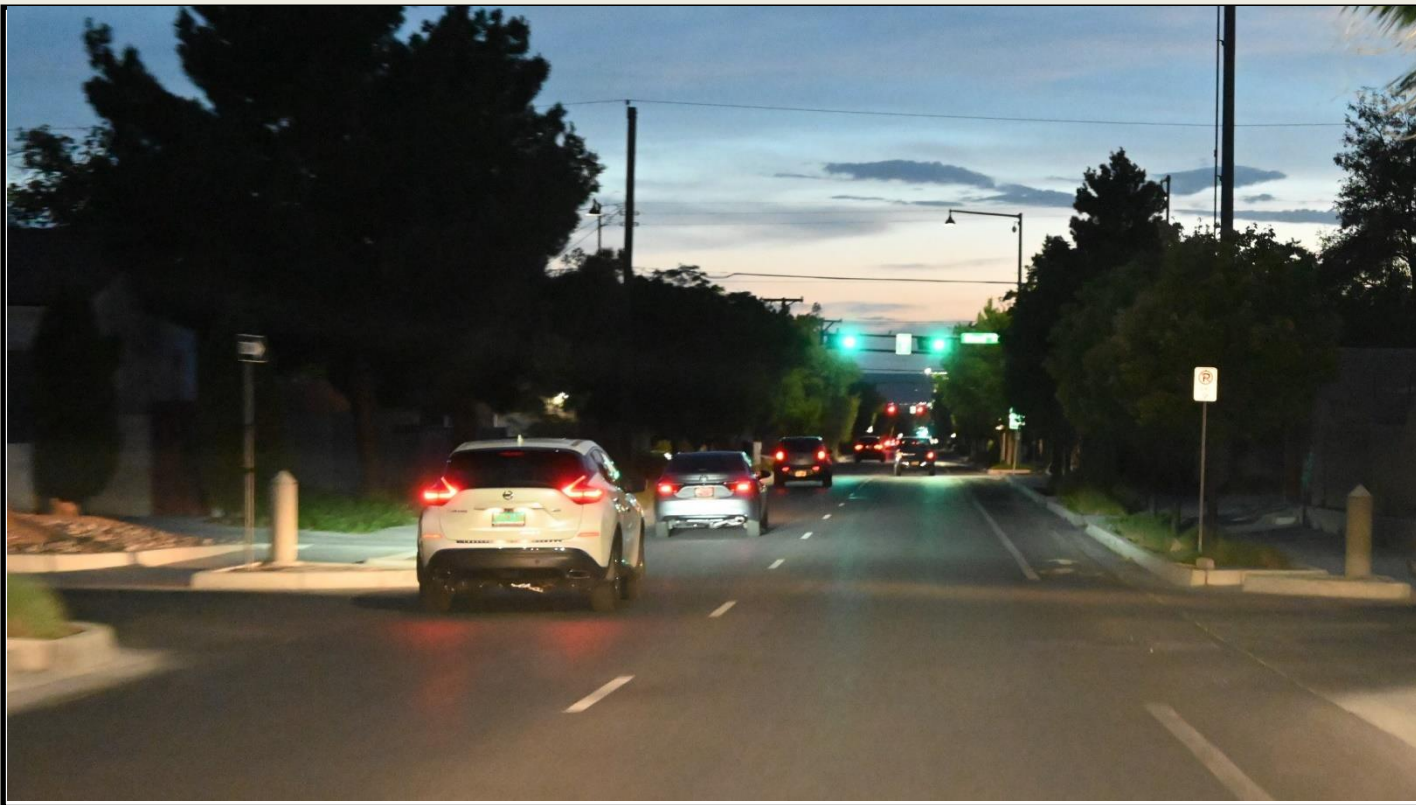
<b>FINDING</b>	<b>7</b>
EXPECTED FREQUENCY	<b>Occasional</b>
EXPECTED SEVERITY	<b>Medium</b>
RISK RATING	<b>D</b>

**OBSERVATION:** Lack of continuous lighting along the corridor.

- SUGGESTION:**
1. Additional lighting needed. Evaluate where lights should be placed. (LT)
  2. Look for opportunities for pedestrian level lighting at parks, schools, school crossings, and hospital. (MT)
  3. Trim trees to keep light from being blocked. (ST)

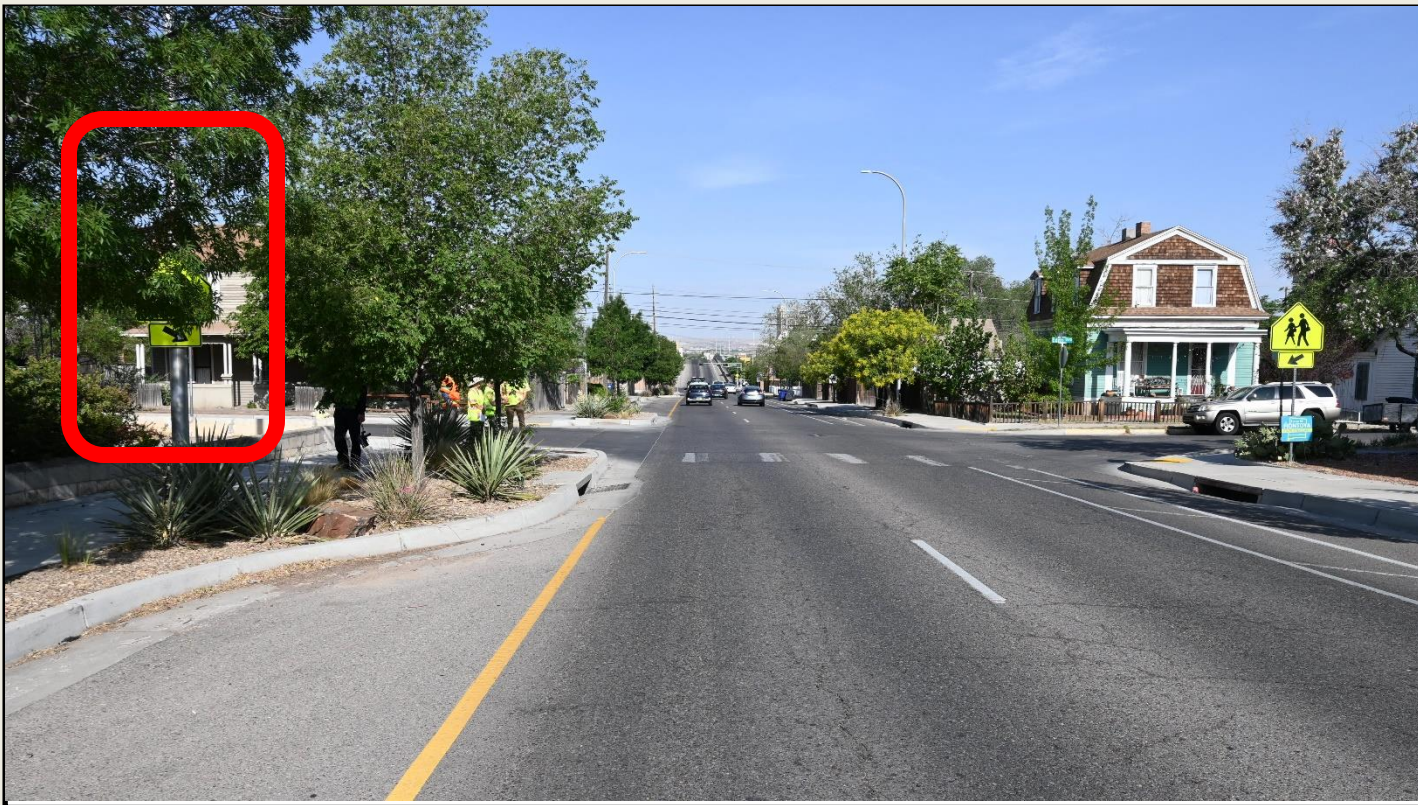
**OBSERVATION:** Landscaping overgrown and blocking traffic signs.

**SUGGESTION:**  
1. Trim trees/vegetation to keep all traffic signs visible. (ST)

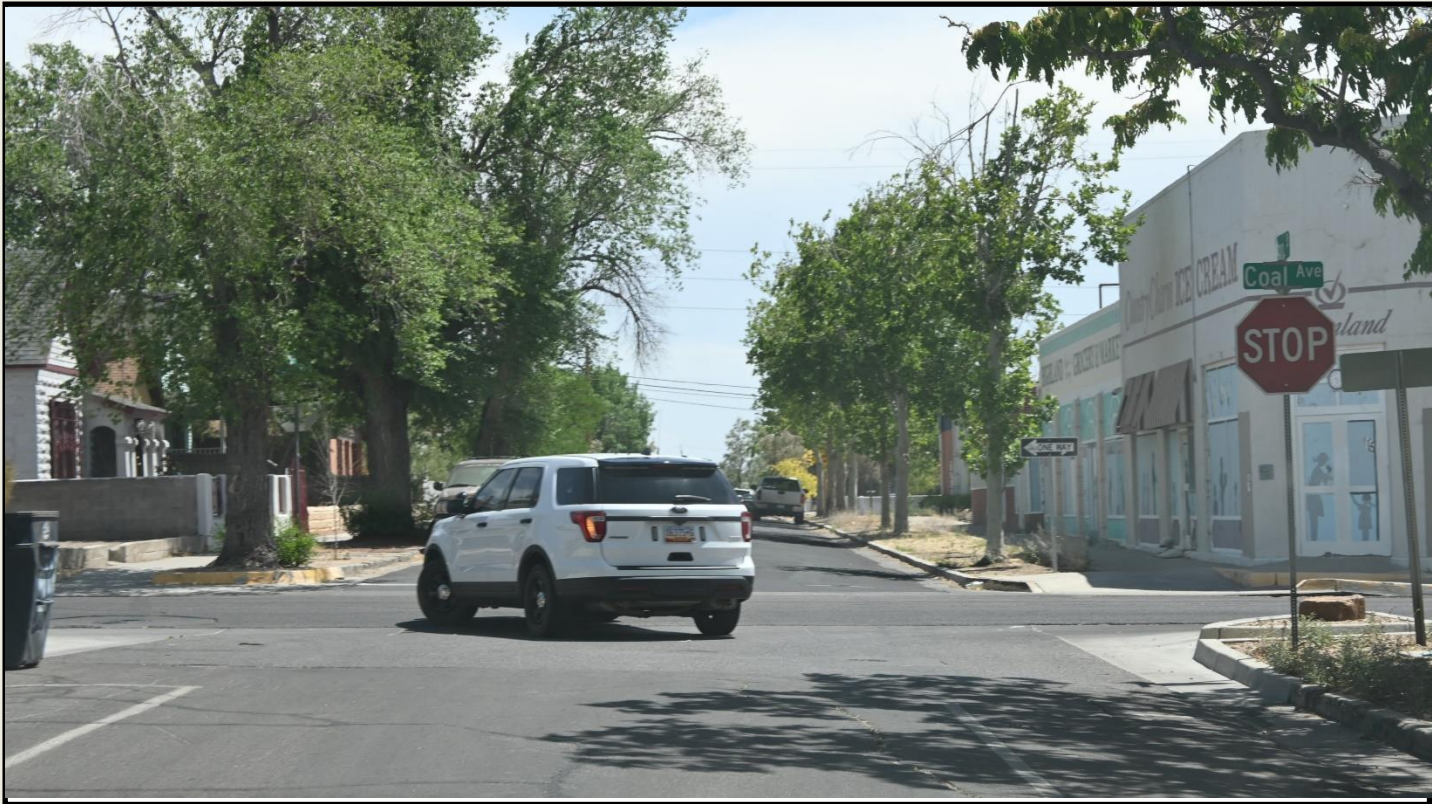
**OBSERVATION:** Inconsistent one way signing (number and placement)

1. Have a uniform one-way signing placement scheme along corridor. (ST)

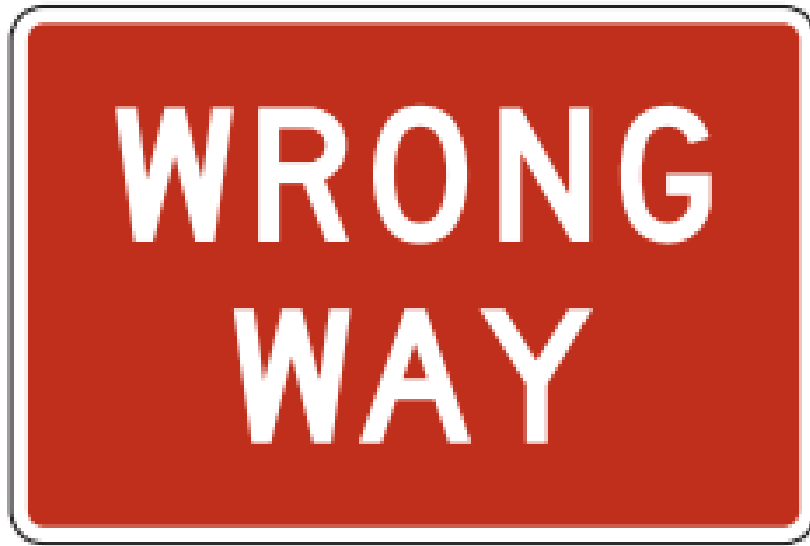
R5-1a

Observation: Wrong way drivers.

1. Install WRONG WAY signing after every major intersection along the corridor. (ST)

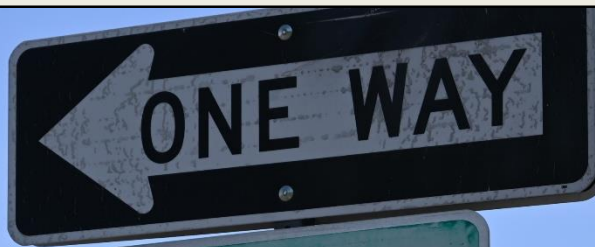
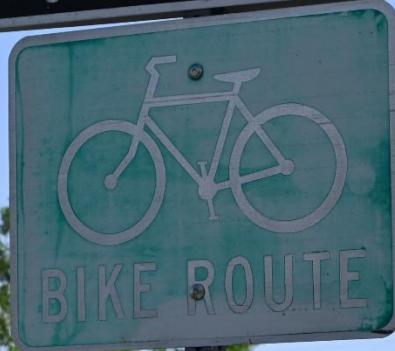
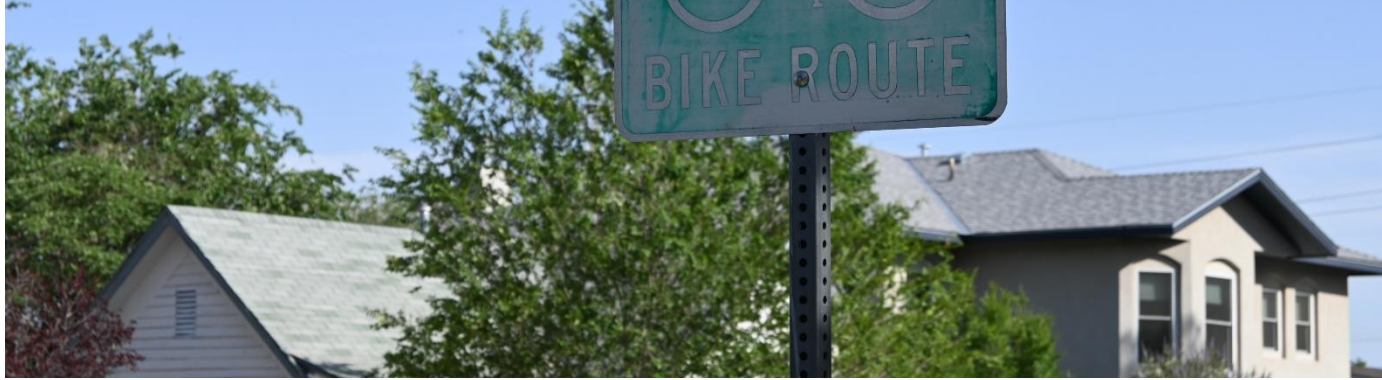
**OBSERVATION:** Some Signs are old and need to be replaced (lack reflectivity)

1. Review and replace old signs. (ST)

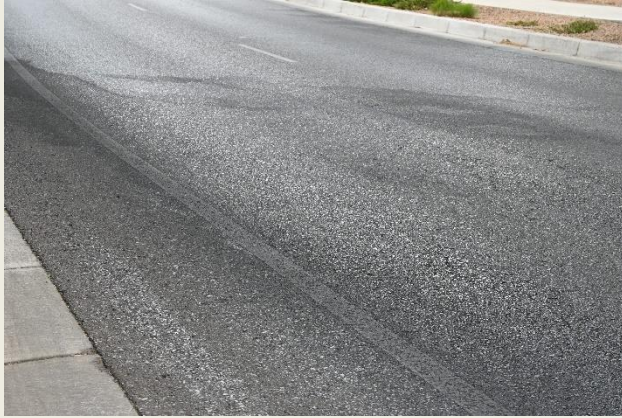
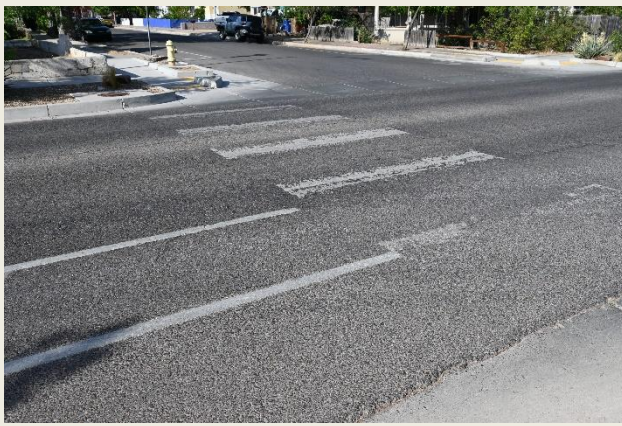
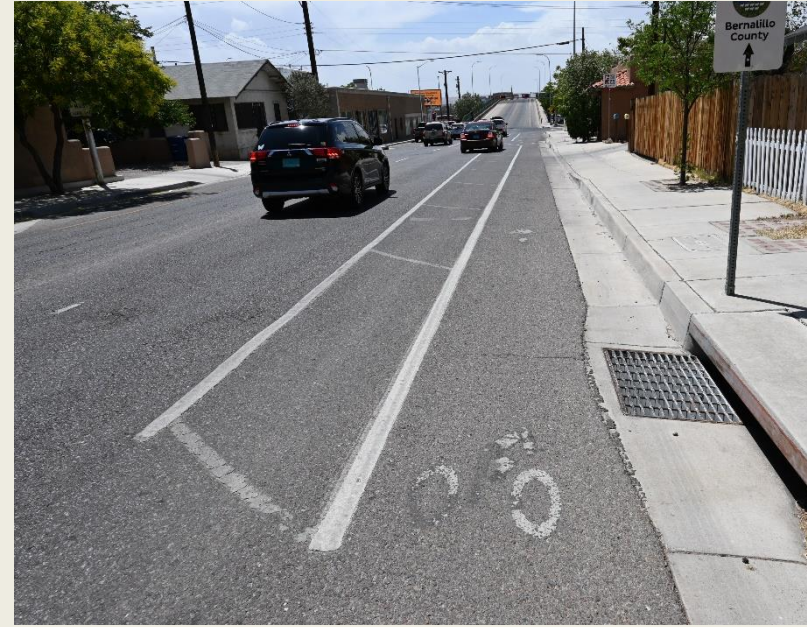
**OBSERVATION:** Pavement markings not visible for motorists, pedestrians, and bicyclists

- 1. Restripe crosswalks and bike lane markings/symbols. (ST)

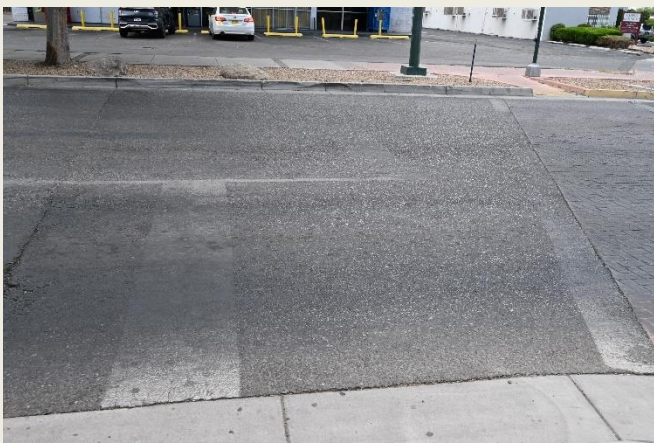
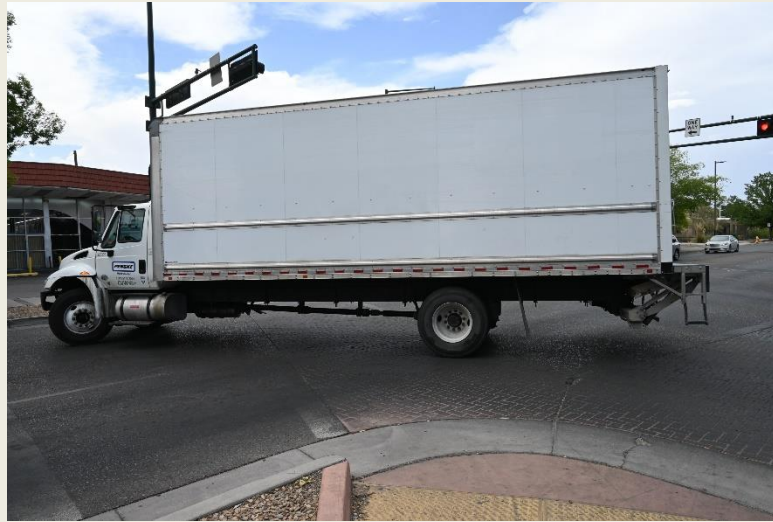
**OBSERVATION:** Westbound Lead Ave to southbound Yale Blvd left turn: stop bar for northbound Yale is faint and stop bar needs to be moved back.

**SUGGESTION:**  
1. Re-stripe stop line and stagger the stop line to facilitate westbound left turn onto Yale Blvd. (ST)

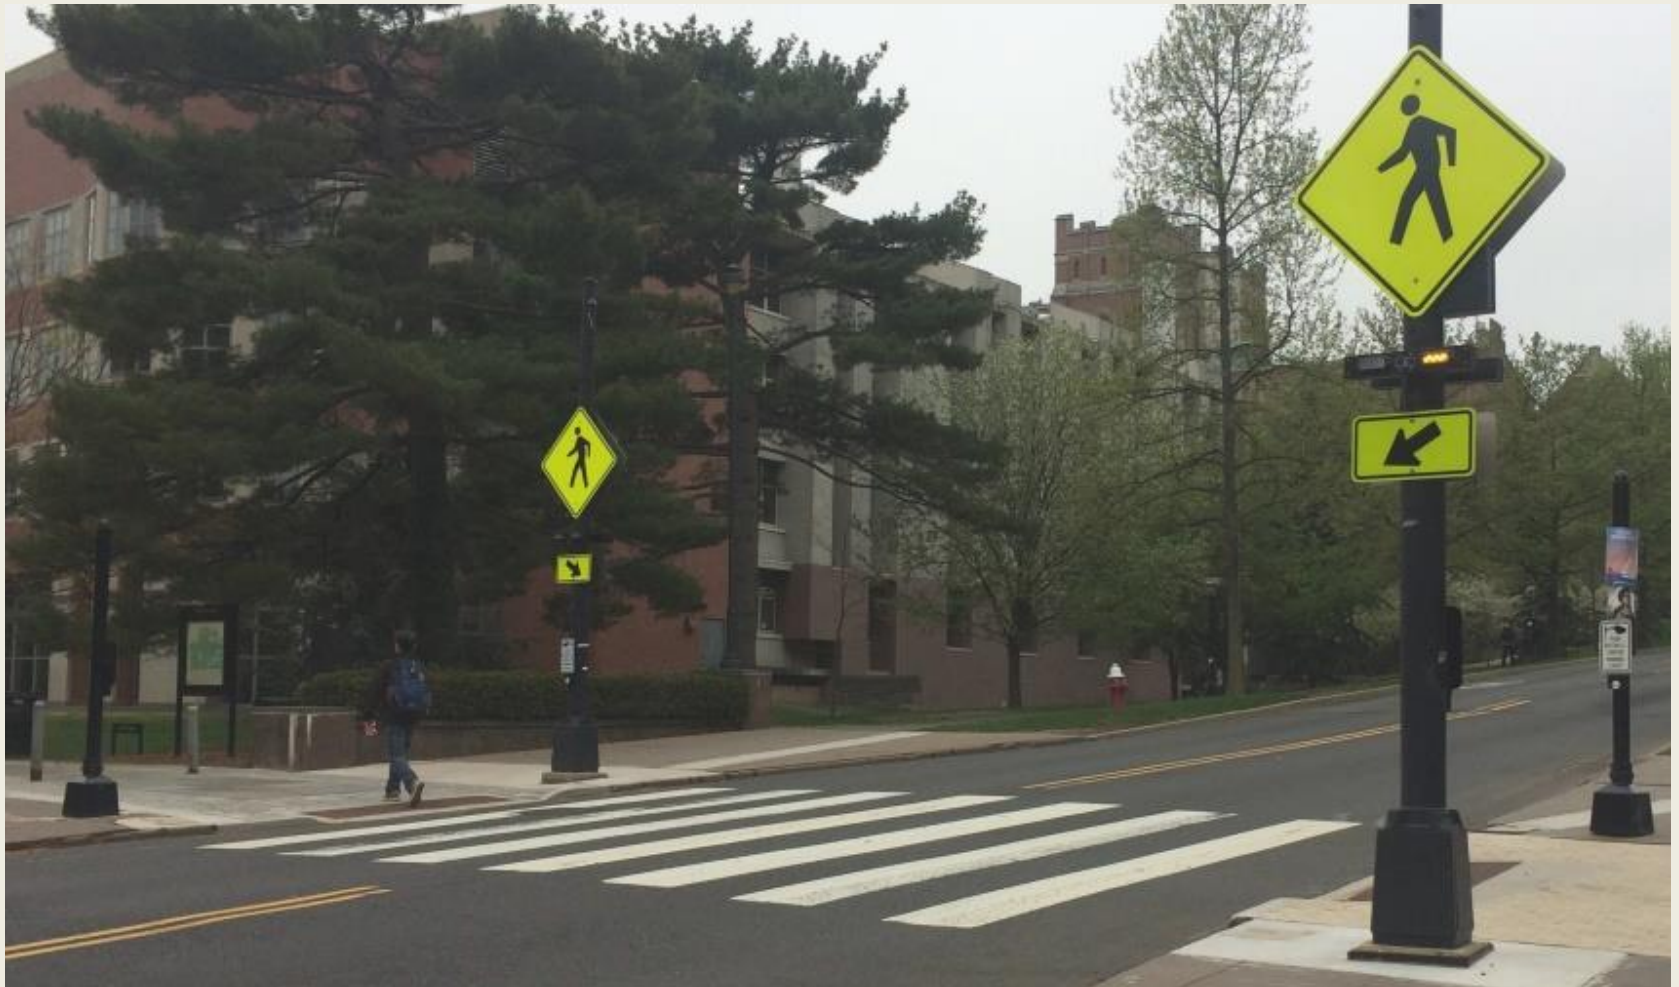
# Crossing Countermeasure RRFB

**OBSERVATION:** Difficult in certain places for pedestrians to cross. Motorists observed not obeying crosswalk laws.

1. Restripe high visibility crosswalks at intersections and school crossings. (ST)
2. Evaluate pedestrian crossing enhancements (see Table 1 STEP Guide) at uncontrolled intersections, especially at locations such as parks, hospital, school crossings. (ST)
3. Conduct pedestrian crosswalk education campaign (MT) and pedestrian crosswalk enforcement for motorists. (ST)
