# **ROAD SAFETY AUDIT**

**Lead/Coal Ave Corridor  
(Washington St to Broadway Blvd)**

*June 10, 2022*

**Prepared for the City of Albuquerque**

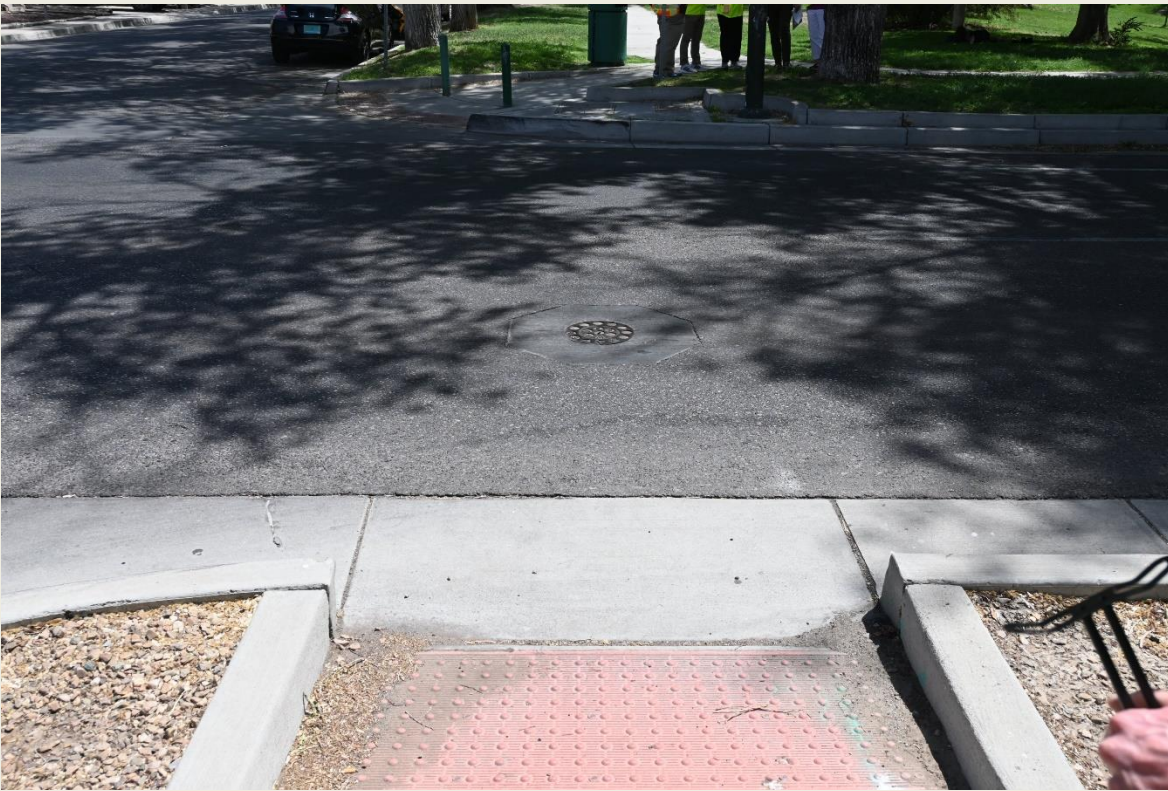
**OBSERVATION:** Some crosswalk ramps are not aligned properly across the street.

1. Modify ramp alignment with future improvements. (LT)

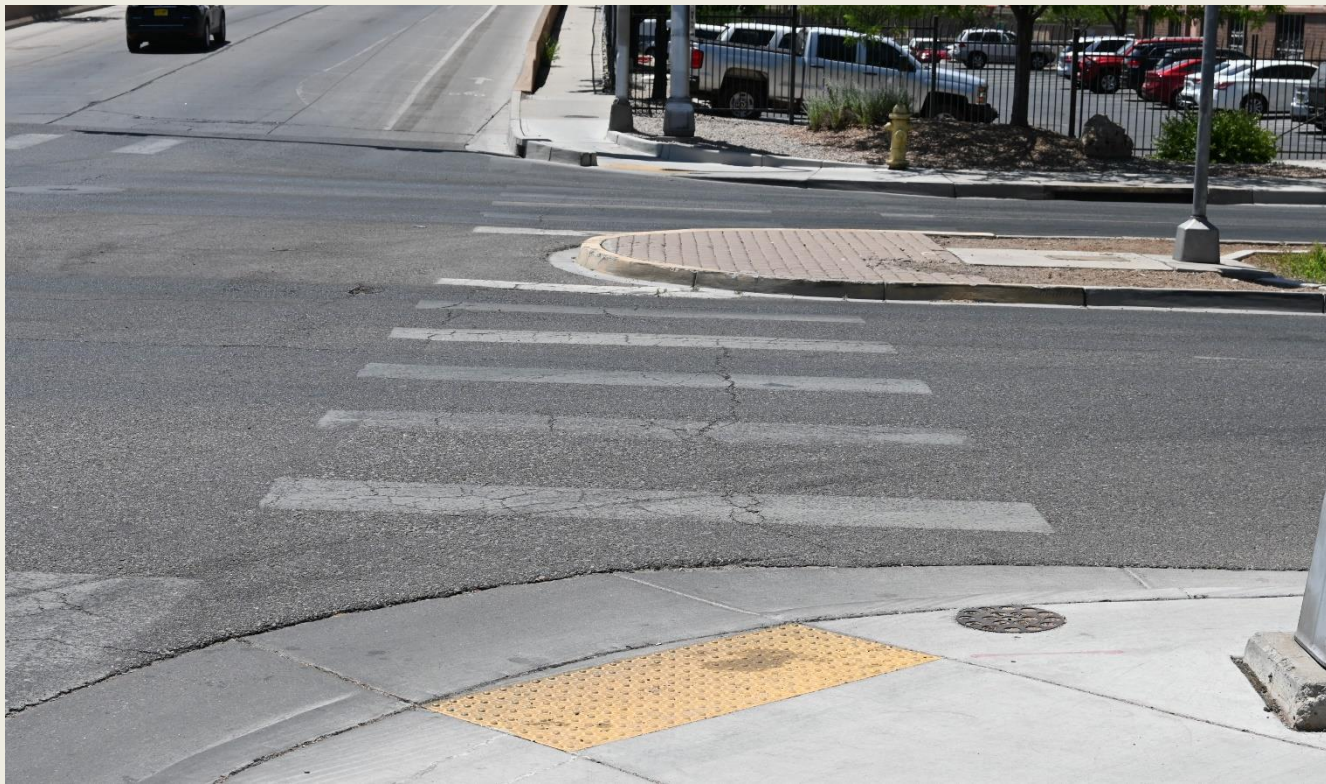
**OBSERVATION:** Medians at some intersections go into crosswalk (not ADA accessible).

1. Modify median with pedestrian refuge to make wheelchair accessible with future improvements. (LT)

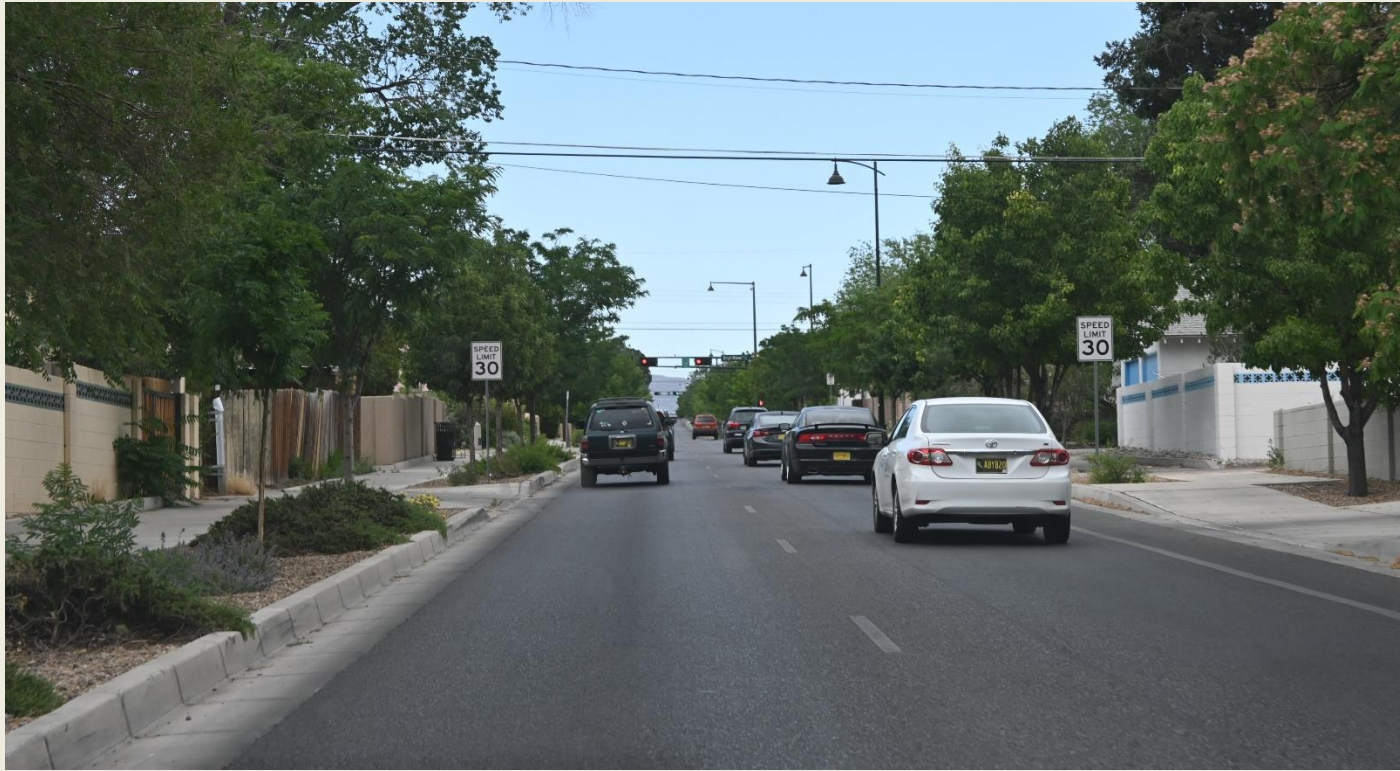
**OBSERVATION:** Turning from the wrong lane observed (for example, a person turned left from the right lane).

**Comment:**  
1. With one lane option, this would not be a problem.

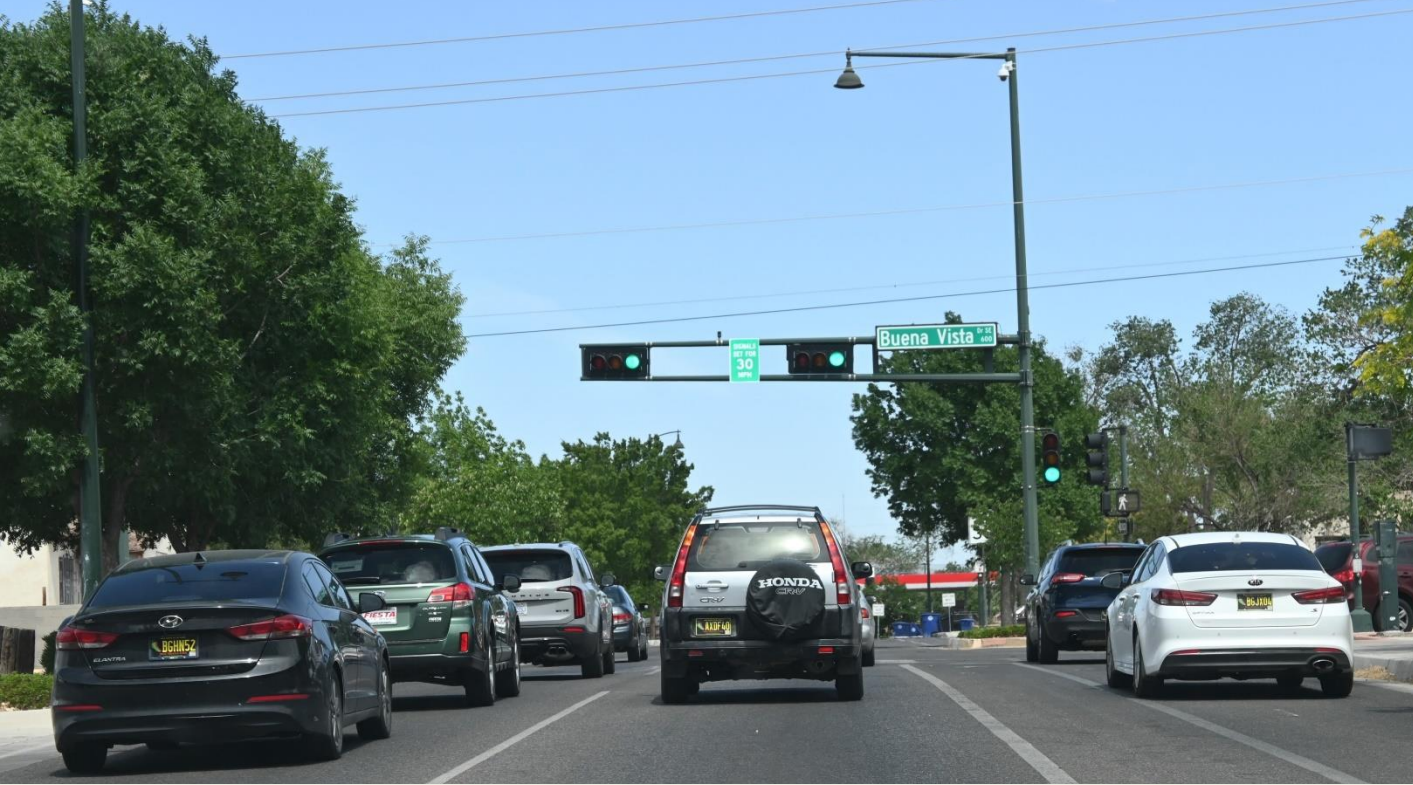
**OBSERVATION:** Failure to obey traffic control devices (Red lights, STOP signs)

1. Consider using red light enforcement cameras at strategic locations. (MT)
2. Ensure all stop signs and traffic lights are visible and not obstructed by landscaping. (ST)
3. Consider larger STOP signs where running STOP signs is occurring. (ST)
4. Install traffic signal backplates for all signal heads and provide reflective borders on backplates to increase visibility. (MT)
5. Increase enforcement. (ST)

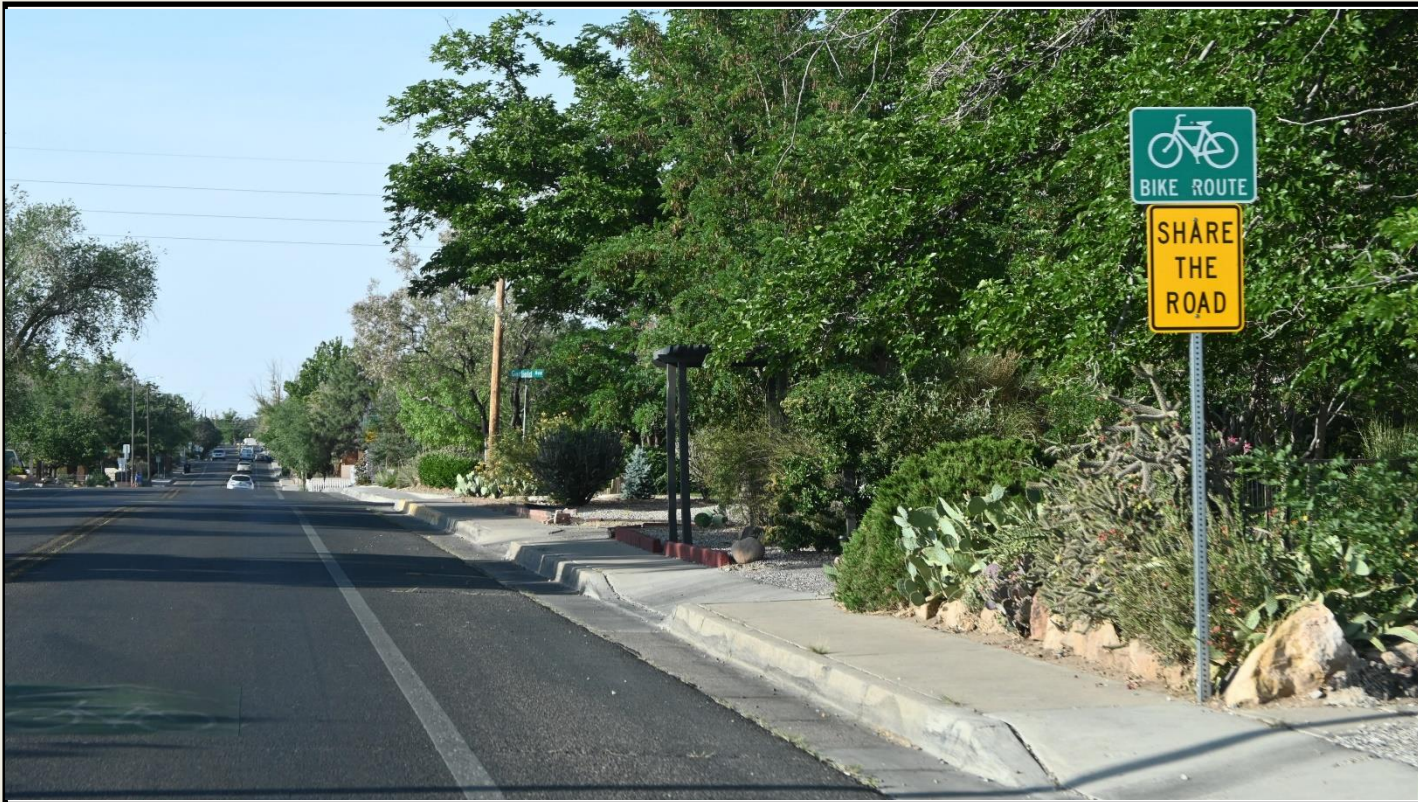
**OBSERVATION:** Bicyclists on sidewalks creating unsafe mix of bicyclists and pedestrians.

**Comment:**  
1. Safer bicycle facilities will reduce number of cyclists on sidewalks.

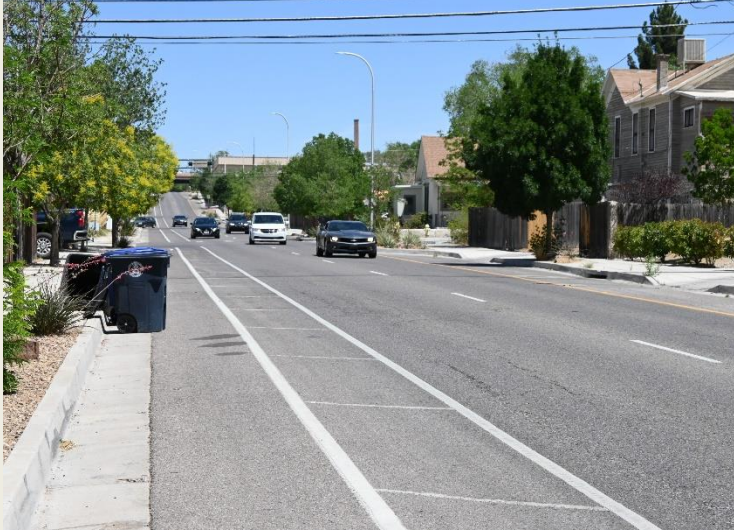
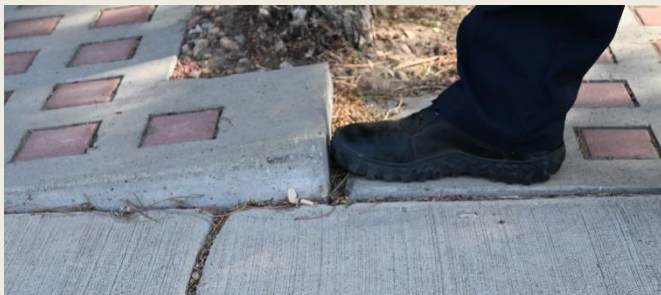
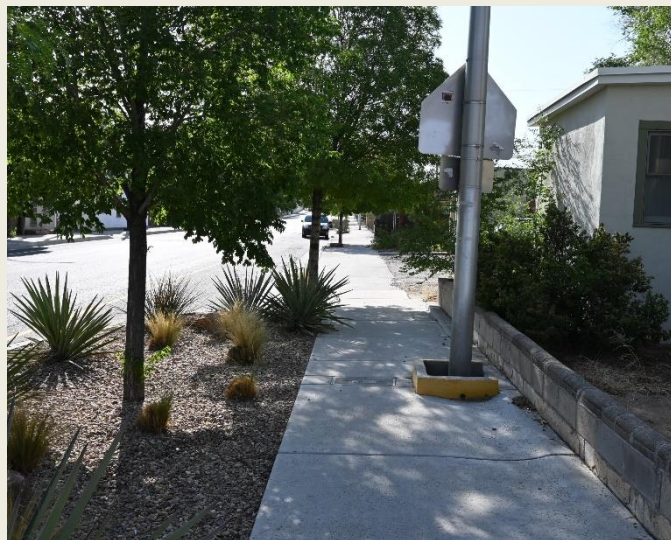
**OBSERVATION:** Objects obstruct bike lanes and sidewalks in places (trash cans, landscaping, and poles).

1. One lane option would provide more room for trash cans.
2. Provide clarification on where public is to place trash cans and work with waste management to see if they could be placed in landscape buffer.  
(ST)
