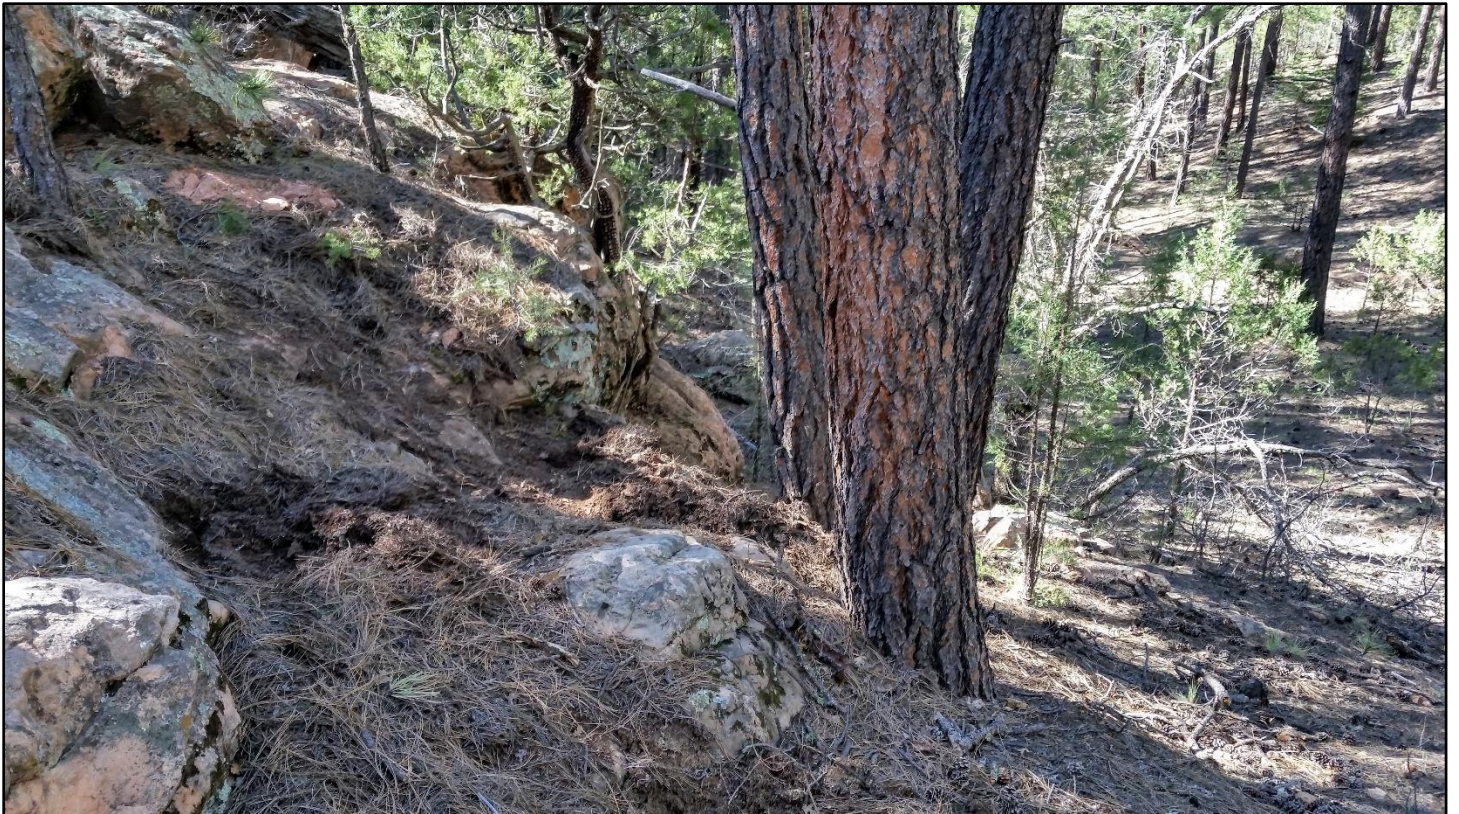
The crew agreed this was the best line to get over the rock outcrop. But a lot of cribbing was needed.

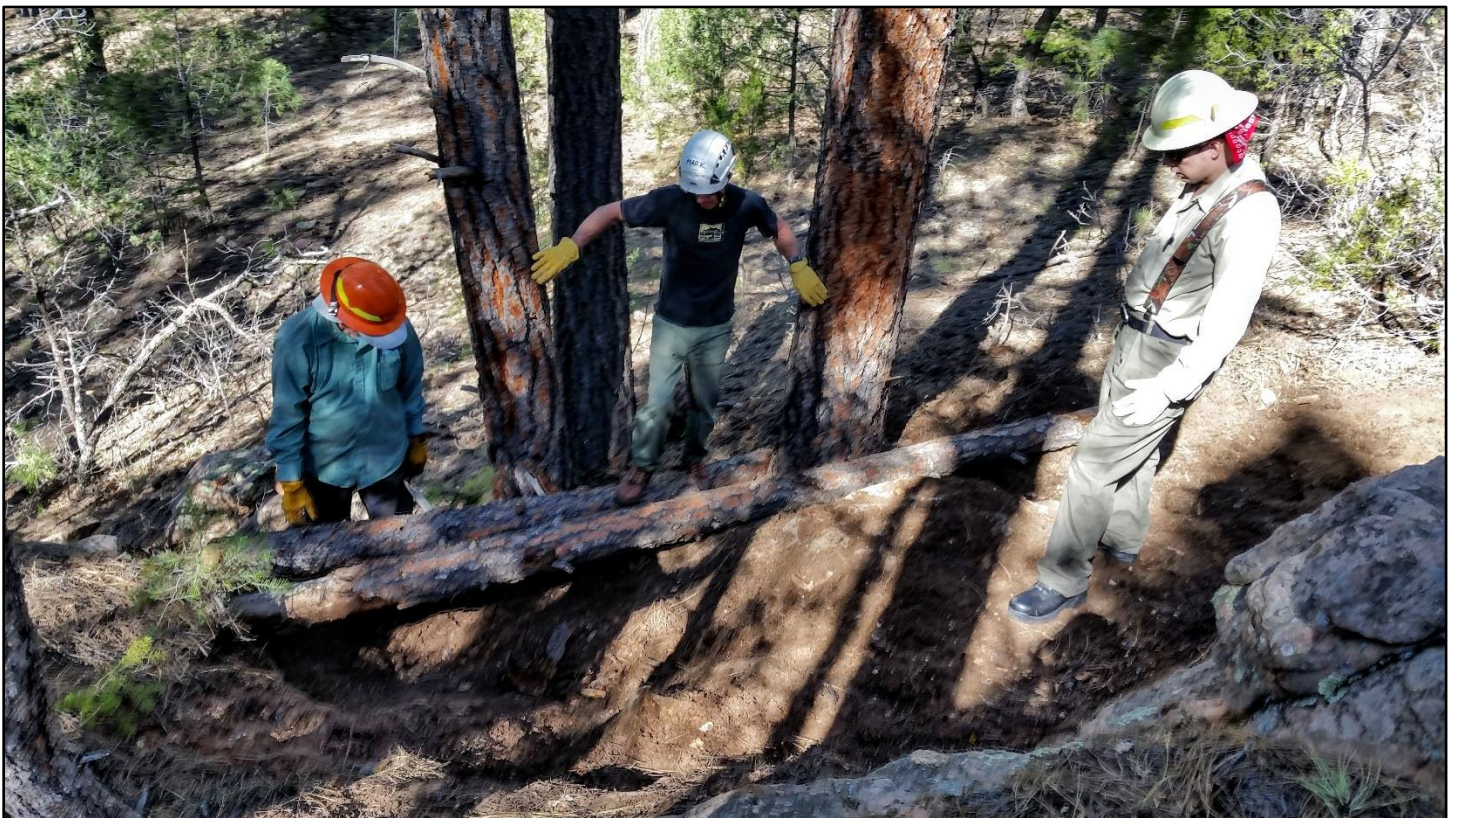
Ok, that boulder is pretty big and this log retaining wall looks really feeble, but it is what it is...

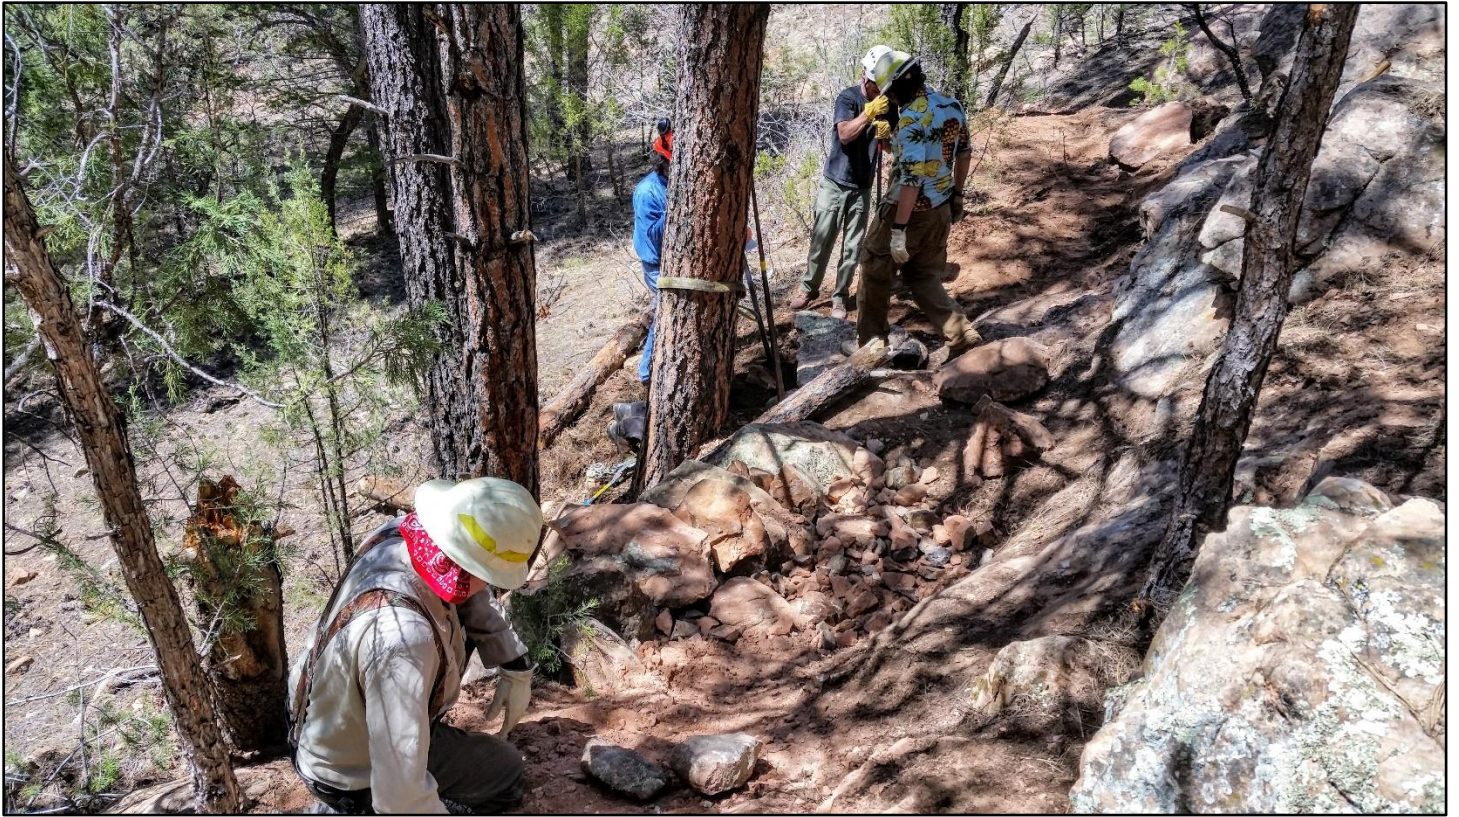
With the upper crib wall complete, some serious backfill was needed to fill the void.

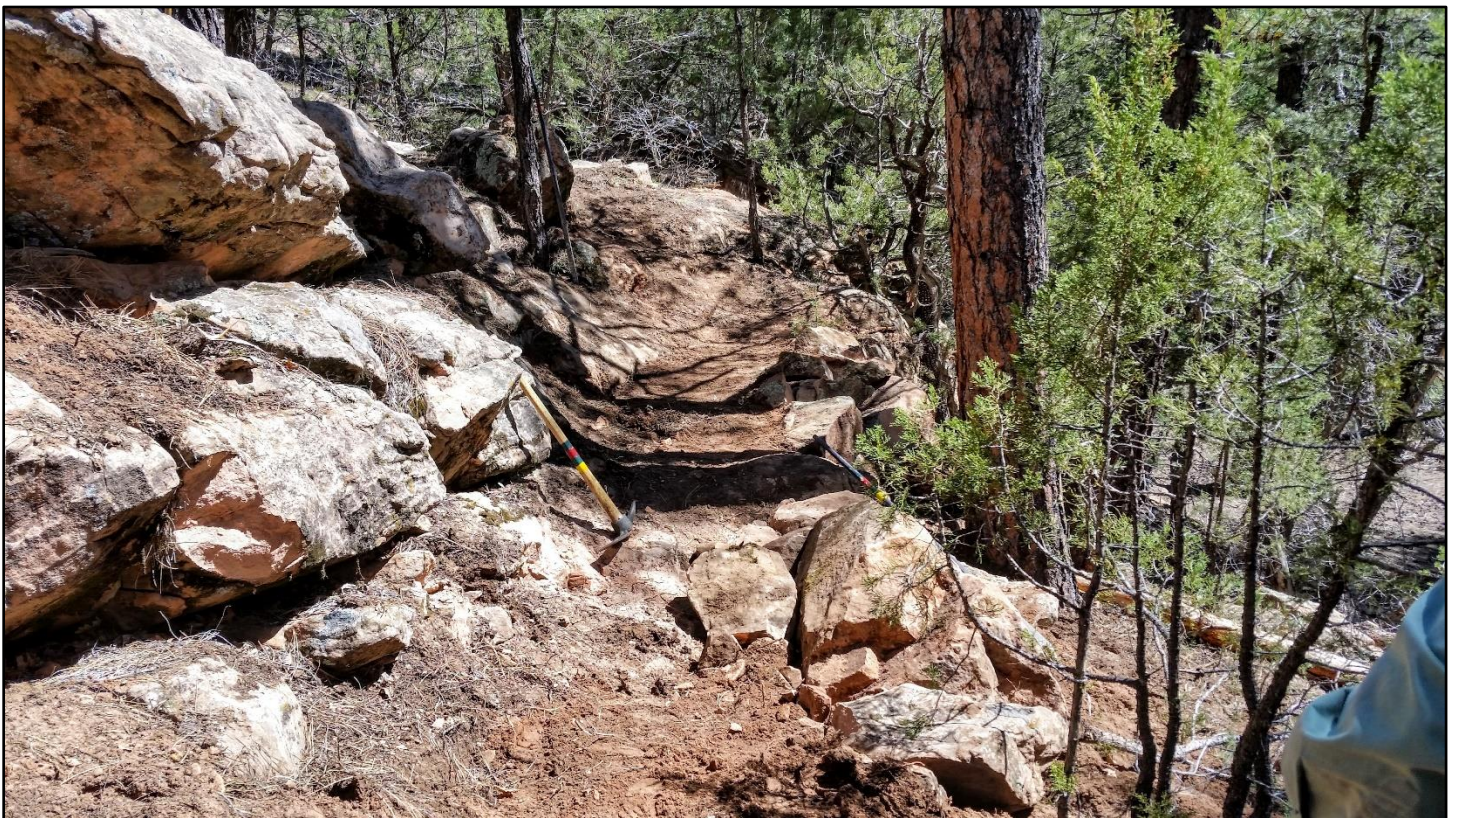
Crib walls are complete but more backfill is needed. We closed the section until we can get back to it.
